INFORM

INFORMATION FOR HISTORIC BUILDING OWNERS

Foundations and Wall Footings

Published by Technical Conservation, October 2008

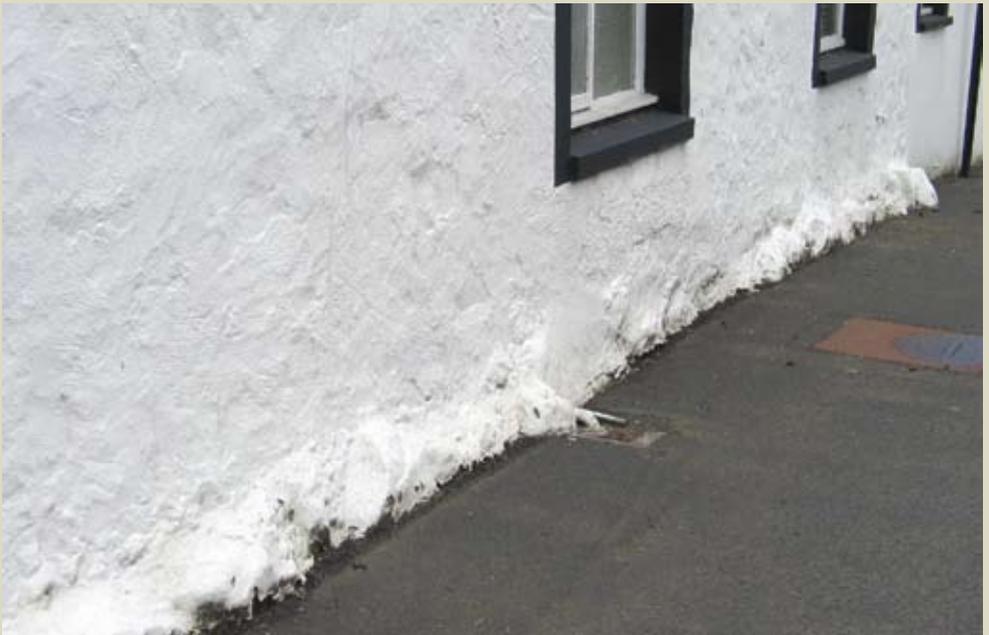
Masonry buildings, from medieval times until the early 20th Century were generally built straight into the ground. For defensive reasons, castles tended to be built upon rocky promontories and, as a result, often had their walls constructed directly from the bedrock. Ecclesiastical structures however tended to be located in a wide range of situations, including river flood plains. Consequently, the walls of such buildings tended to be constructed on a broader foundational pad so that the structural load could be spread over a larger ground area. As the construction of masonry domestic buildings became more commonplace during the 18th Century, large rough boulders were laid in a shallow trenches to create rudimentary foundations. The dimensions of these stones tended to be larger than the width of the wall that was to be built on top; so many buildings of this period can still be found with exposed foundation stones, or with a distinct protrusion occurring at the wall footing.

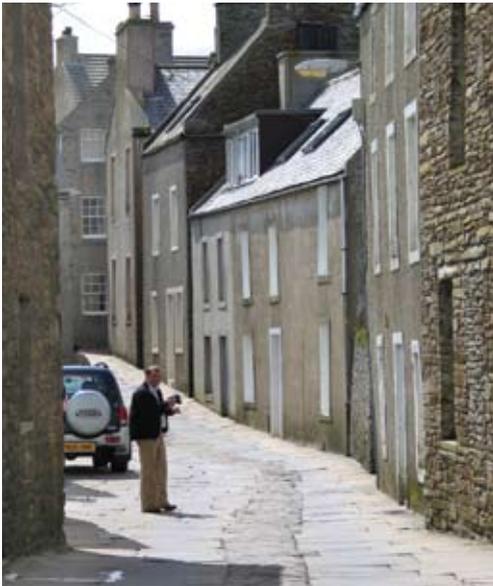
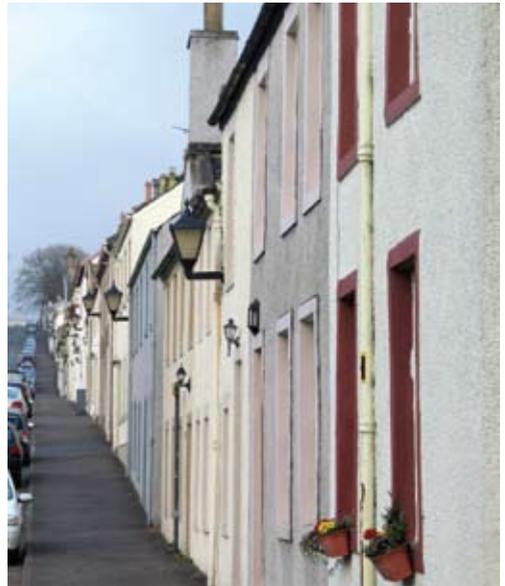
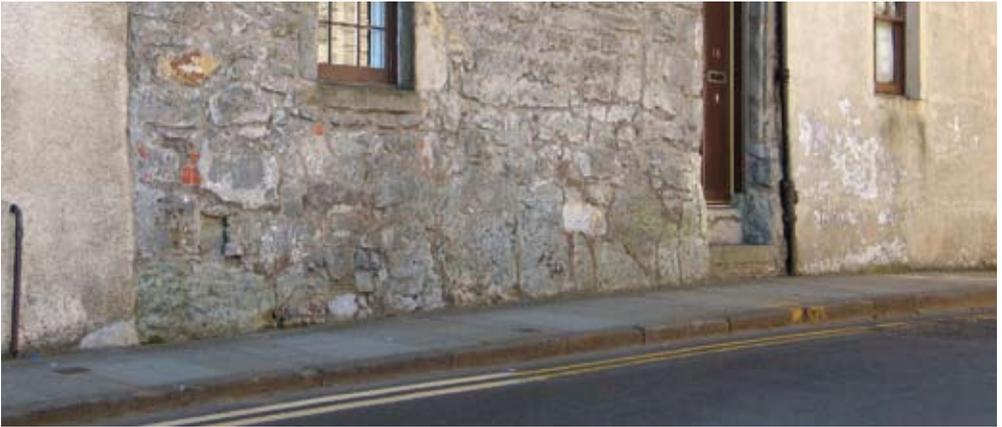
Where buildings, or groups of buildings, were constructed up the ground slope, stepped foundations had to be created, especially if the buildings were adjoining. Whilst this meant that internal ground floor levels had to be

stepped, over the length of the building it was inevitable that some part of the foundation also acted as a part-retaining wall structure against the rise of the ground. Inevitably, this created more of a problem as the foundation and wall footing construction could lead directly to water penetration of the interior where the floor was lower than the external ground level.

Occasionally, the entrance doorway was located in the highest part of the slope with the floor made up above the external ground level to avoid this problem. Access into the property was over a raised entrance platt or step as this prevented surface water from gaining direct access through the doorway. But, this arrangement still left the problem of dealing with any rainwater discharged from the building itself, and the need to control surface water discharging down the slope. On steeply sloping sites, complex original arrangements of gutters, slabs with channels cut in them, bridging entrance platts and applied skirting blocks helped, although later external road and pavement surfacing works can often add to the difficulties.

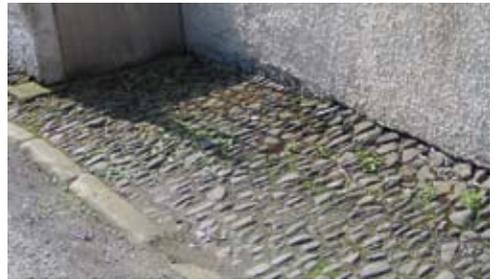
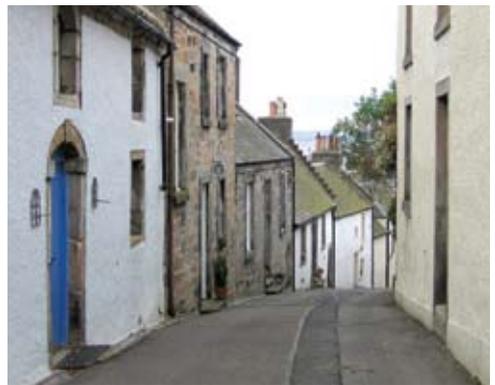
Pavements adjacent to buildings should, ideally, be laid on a slope that falls away from the wall as this helps direct rain water from the footing towards the road-side gutter. Prior to the introduction of tarmac or concrete slab pavements, traditional detailing could involve the construction of a pavement made up from rows of thin cobbles or split stones. To ensure that these discharged water properly the stones were laid at right angles to the building thereby allowing surface water to drain down the slope between the stones. Sometimes, such pavements also included the construction of an integrated cobble lined gutter which took the collected water away from the area. A further traditional detail that could be found is the use of a dimensioned kerb stone used to contain the cobbles and to provide a drop into the adjacent gutter.

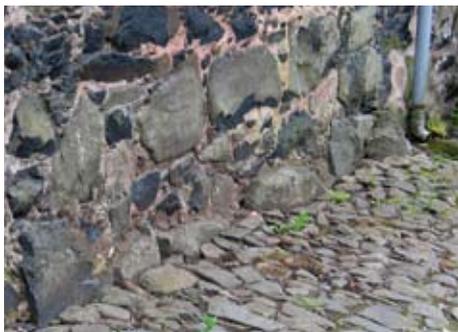
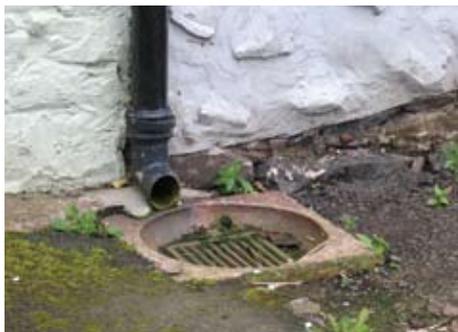
Such traditional arrangements have often been lost where pavements and road improvements have been made resulting in the external ground level rising. Such later alterations make it all the more important to ensure that any sub-surface drains function effectively, and that pavement gullies are not blocked up by growth or other debris. Often, another problem created by

the build up of pavements leads to creating a small well at the foot of the building into which rainwater is discharged. This arrangement can also encroach onto the external face of wall foot ventilators, allowing water access directly into the sub-surface of the building through the vent slots. Unfortunately, increases in modern road level surfacing sometimes also eliminates

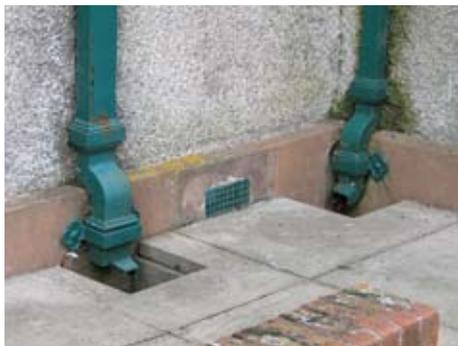
the gutter, running the risk of surface water flowing back towards the building's wall footing and foundations, especially if the surface slope away from the wall is slight, or non-existent. In addition, the impermeability of modern paving materials can trap underlying moisture adjacent to the wall footing.

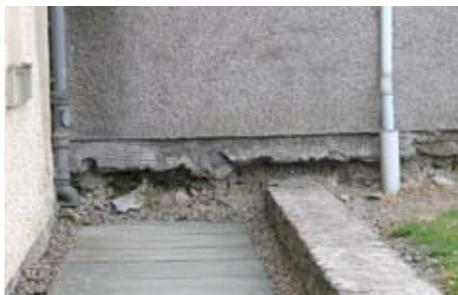
It also needs to be recognised that the regular application of winter road salt on pavement and road surfaces can be particularly damaging. Some stones, especially sandstone, are at a considerable risk of induced decay where the salt splashes against the building as salt contamination can lead to the accelerated degradation of the stone. The first signs of this happening usually occur in the vicinity of the masonry joints and beds where there is an easy route for salty moisture movement through the lime mortar. Here, it is best to try to prevent winter road salts to coming into direct contact with the masonry.

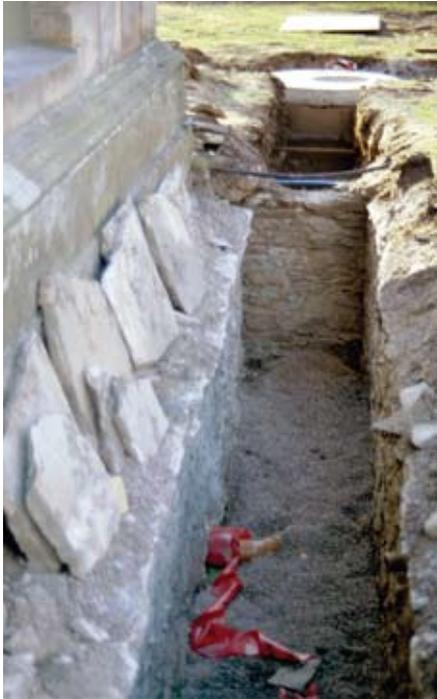
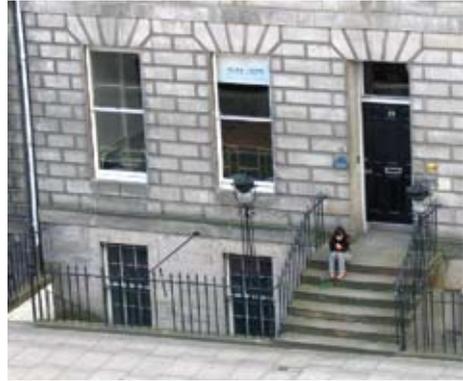
In the late 18th and early 19th Centuries the beneficial use of air drains around buildings was well recognised. The air drain allowed evaporation of moisture from exposed wall faces into the constructed trench as a method of dealing with rising damp in wall footings and foundations. Used on a small scale in mansion houses, the same principle

was applied to urban developments where basements were constructed to either a half or full level below the public pavement. By aligning and constructing the building in from the pavement edge, a combined air-well and light-well was created with the open space readily allowing moisture to evaporate from the lower wall into the free air. As part of the arrangement, care needs to be taken to ensure that water does not build up and flood into the bottom of the air drain or well by ensuring any drains flow freely.

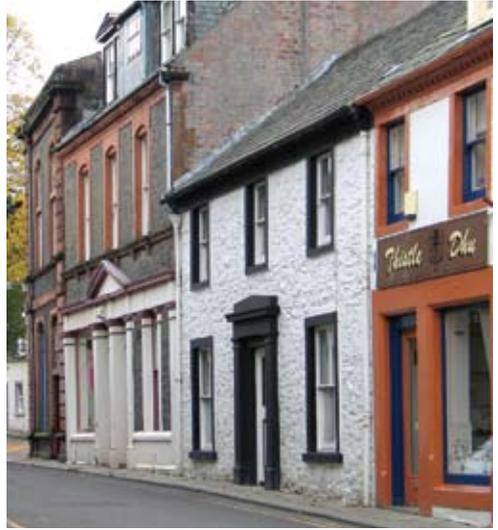
In Victorian times the application of a layer of asphalt through the wall thickness above the foundations created the first serious attempt to put a damp-proof membrane in traditional construction. Unfortunately, due to the thickness of the layer of the asphalt, over time this seal can be squeezed out, thinned and broken due to the imposed load of the building constructed on top of it, to become less effective.

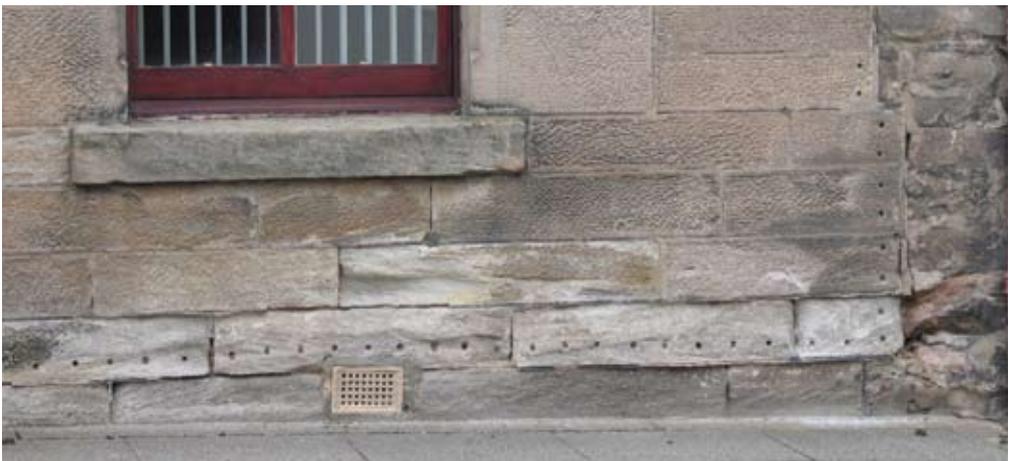
Attempts are often made to inject chemicals into a course of wall foot masonry above foundation level to try to prevent water from rising up through the structure. This creates a chemical barrier within the structure of the stone. The technique is only likely to be effective in sandstone and is not so successful in less porous stones like granite or whin. Where used, the technique leaves the disfiguring tell-tale signs of a series of horizontal (and sometimes vertical) holes into which the chemical injection process was carried out. Other proprietary methods involving cutting

into the wall might include active and passive electro-osmotic techniques where electric currents are passed through the installed system in an attempt to control dampness.
