INFORM

INFORMATION FOR TRADITIONAL BUILDING OWNERS

Decorative Paint Finishes: Graining and Marbling

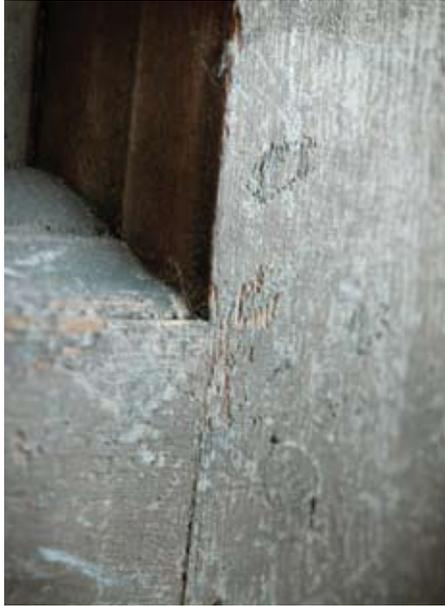
Severe deterioration can lead to the loss of decorative finishes

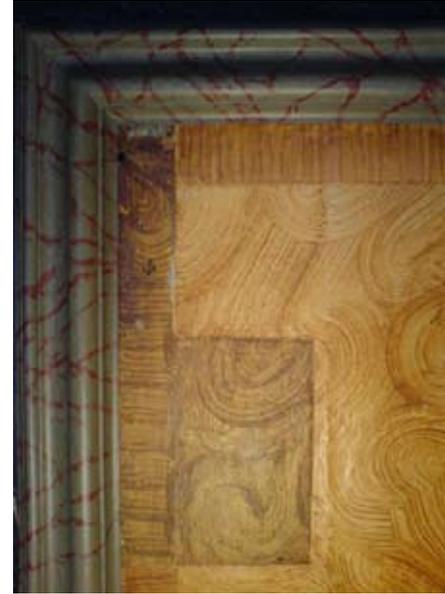
Decorative finish reproduced from a small surviving fragment

Uncovered areas of historic graining or marbling of a sufficient size can provide an indication of the original patterning and colour of the scheme, so that the scheme can be reproduced over a larger area. An effective reconstruction should achieve the same quality as the original and should reproduce the patterning, colours and texture using templates of the original detailing set out in their repeating pattern dimensions.

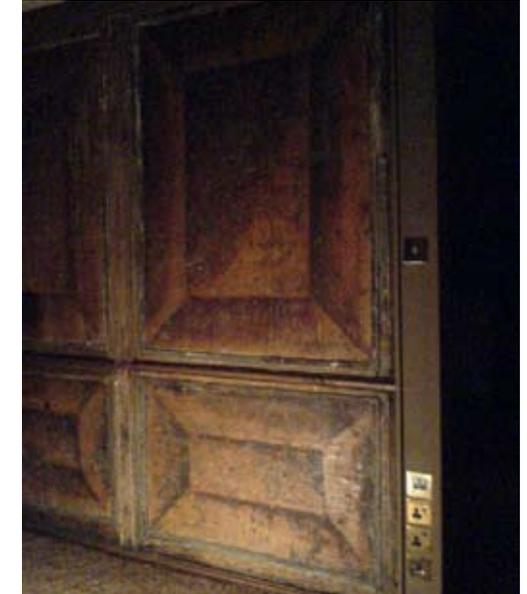
Fully reproduced decorative scheme

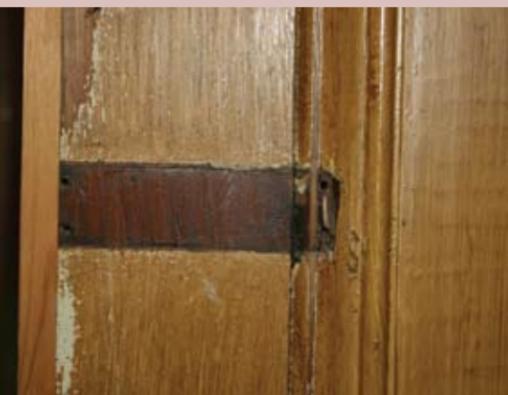
Early marbling showing beneath a later paint scheme which had been previously been covered by a fitting

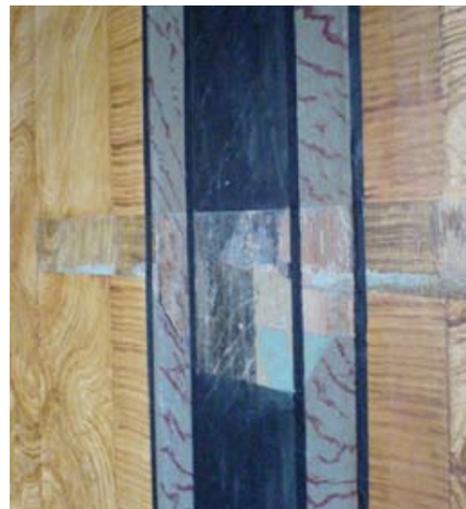
A decorative scheme uncovered and reproduced

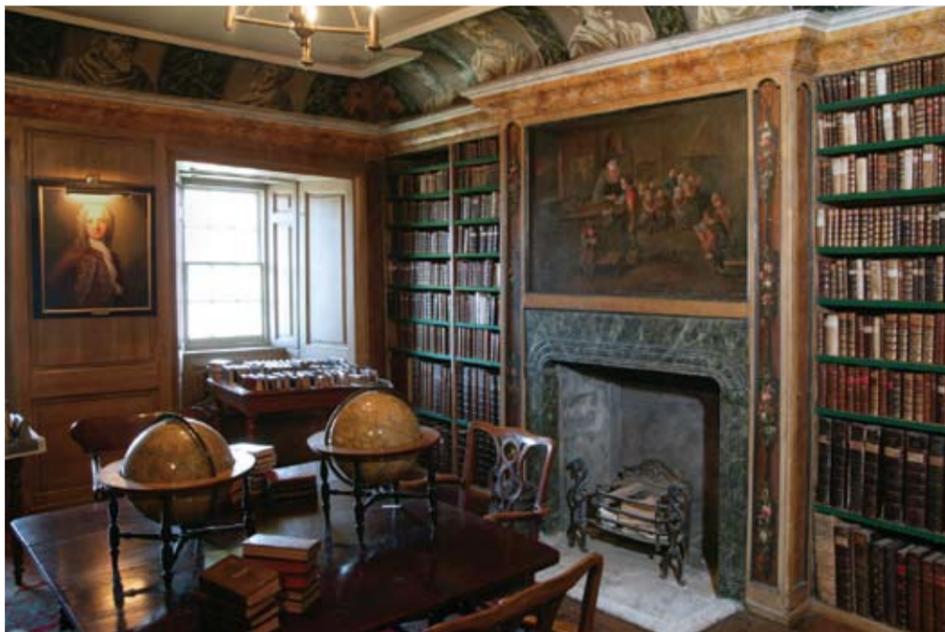
Room showing extensive use of graining and marbling

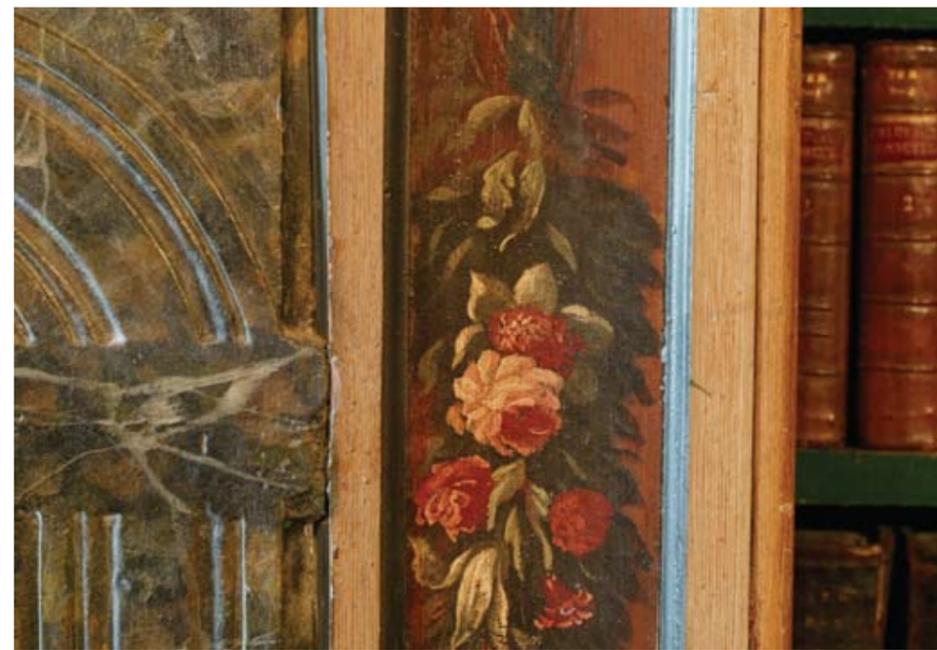
Marbling employed on a fireplace

Marbles were copied using similar methods to those used for graining. Specific techniques varied according to the marble to be imitated, and the base to which the finish was to be applied. A distemper ground rather than an oil ground was used where the finish was to be applied to plaster. For darker marbles, a dark ground would be applied, onto which lighter veins would be painted. The surface preparation was crucial to achieve a degree of smoothness which would represent a polished marble.

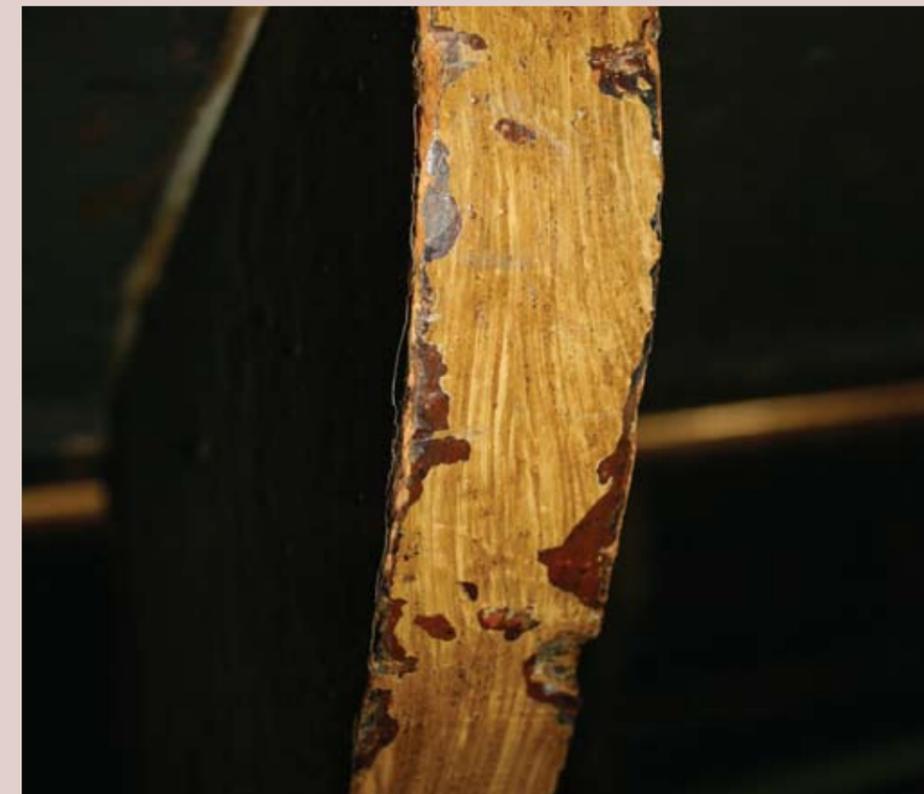
Wear and tear can cause damage to decorative paint finishes

General wear and tear, central heating, open fires, damp walls, condensation, inadequate ventilation, poor previous repairs and inappropriate redecoration can all lead to deterioration of paint finishes.
