INFORM

INFORMATION FOR HISTORIC BUILDING OWNERS

Domestic Boundary Walls

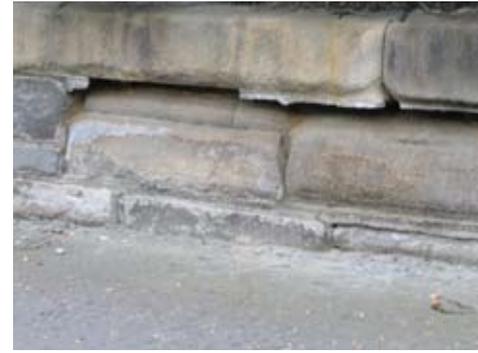
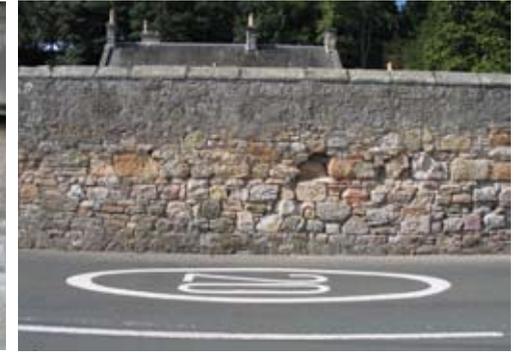
Wall foot damage

Another area where boundary walls are vulnerable to decay is in the vicinity of the wall footings - especially where there is a risk of salt being laid on adjacent roads and pavements during winter months. In these circumstances, the salt can be regularly splashed onto the stonework and this can lead to a significant breakdown of the mortar and the stone.

In recognising that it is difficult to avoid circumstances where walls are adjacent to surfaces that are routinely treated with winter salt, repairs should be carried out to both stone and joint work whenever signs of degradation are noted. If left unattended, the salt contamination can continue to decay the masonry to such an extent that it can undermine the structural stability of the wall, leading to its eventual collapse. In some cases this will mean replacing badly eroded stones to stop the process getting worse.

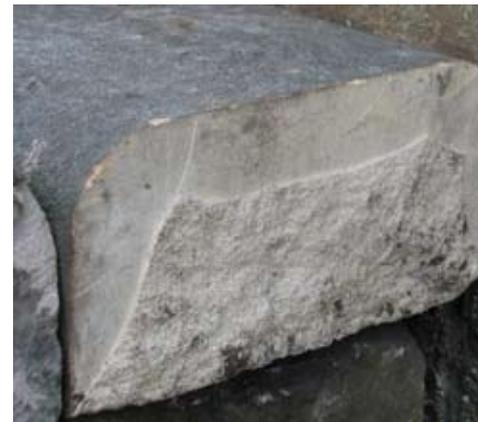
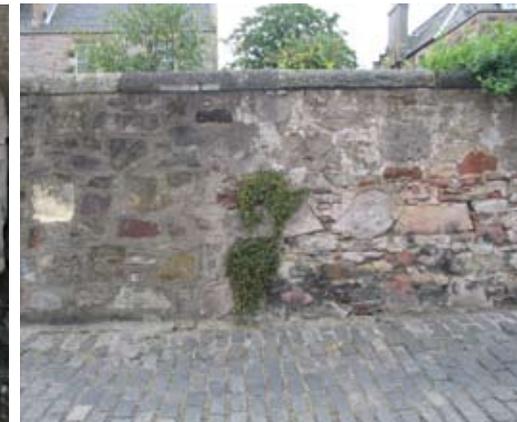
Adjusting boundary walls

The modern technique for adjusting boundary walls frequently involves using a mechanical saw to reduce the length of some cope stones. This can leave an unsatisfactory finish as the technique also involves physically breaking the stone along the weakened lines of the mechanical saw cuts. Where cope stones require to be shortened the cut end of the stone should be carefully hand worked to match the original masons tooling.

It has also become commonplace to rebuild masonry walls in a style that does not reflect how they were originally constructed. Although the stones may be re-used in the rebuild, through lack of recognition that the stones were originally laid in horizontal courses, they now tend to be somewhat thrown together in a haphazard manner. This not only changes the appearance of the wall, it also creates a build that less strength than the original construction.

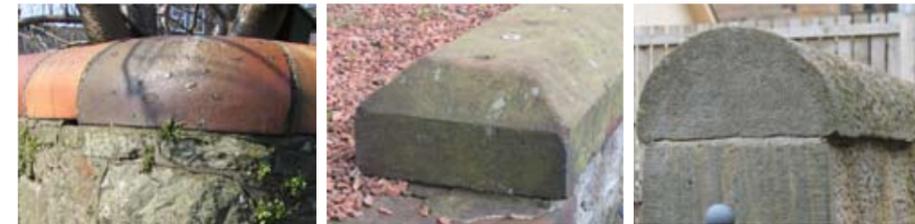
To accommodate changes in the ground level between properties, cope stones may be carefully detailed to have their moulded profile curved, angled or returned in vertical steps to maintain the wall height above ground level. Occasionally, cope stones may also rise to create a lintel over doorways set within the wall. In doing so, the lintel helps stabilise the wall by providing a physical link that structurally ties the wall on either side of the doorway together.

Where there is a need to terminate the length of the wall, vertically set square-section large stones, the width of the wall, were sometimes placed on their edge and bound into the stonework to protect the core from being weathered. Features such as this should be retained as they are functionally efficient.

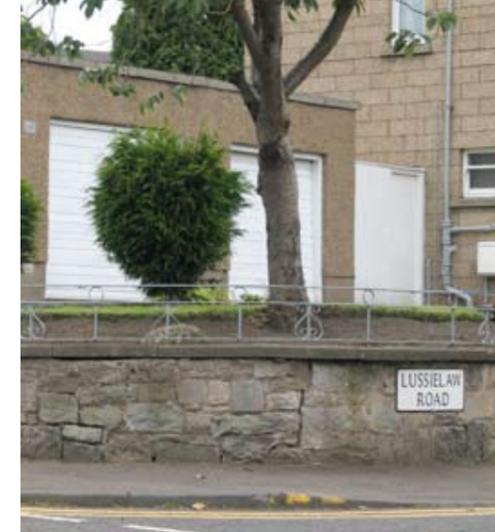
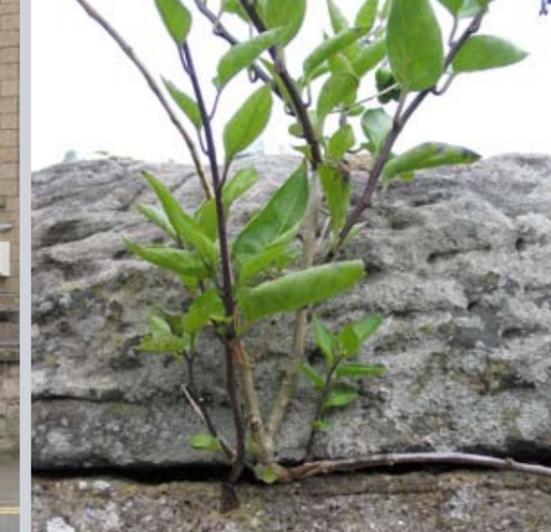
Where a wall has not been maintained, and the pointing material has become loose or dislodged, the ideal situation for the establishment of damaging plant growth has been created. Vegetation is often found growing out of the face of walls where the joints are open and this can lead to more damaging root penetration into the wall core. If this occurs below the cope the development of the roots can lever the cope stone out of place, and disrupt the pointing between the individual stones. This, in turn, can allow water to penetrate the core, nourish the roots and lead to further deterioration through encouraging the growth. Where vegetation has established itself on a boundary wall it should be quickly removed, and any open joints and beds repointed as soon as possible to prevent recolonisation. More established growths should be removed by hand weeding, ensuring that all the roots are also removed to avoid leaving potential paths for water ingress as they decay.

In situations where the growth has been left unattended for some time, and the root penetration is significant, the coping stones may

have to be up-lifted and small sections of the wall down-taken, to completely remove all the roots from the wall core prior to the wall being rebuilt. As far as possible the stones which have been removed should be replaced in their original position taking care to align with the original building courses.
