INFORM

INFORMATION FOR TRADITIONAL BUILDING OWNERS

Structural Joinery

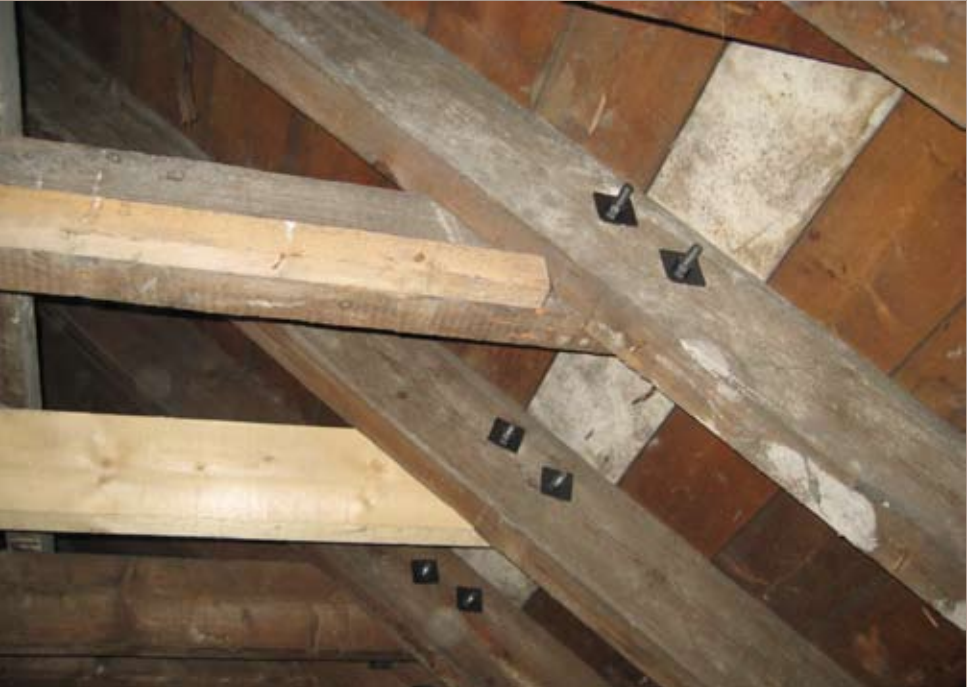
Strengthening of the joint with bolts

Areas of sound timber can become less stable by the loosening or failure of the iron nails, common at tie beams and the apex joint. Where possible the old nail should be removed if it has failed, and a stainless steel bolt and washer set fitted, remembering that old nails can assist in dating the building. Normally one bolt is sufficient for stiffening.

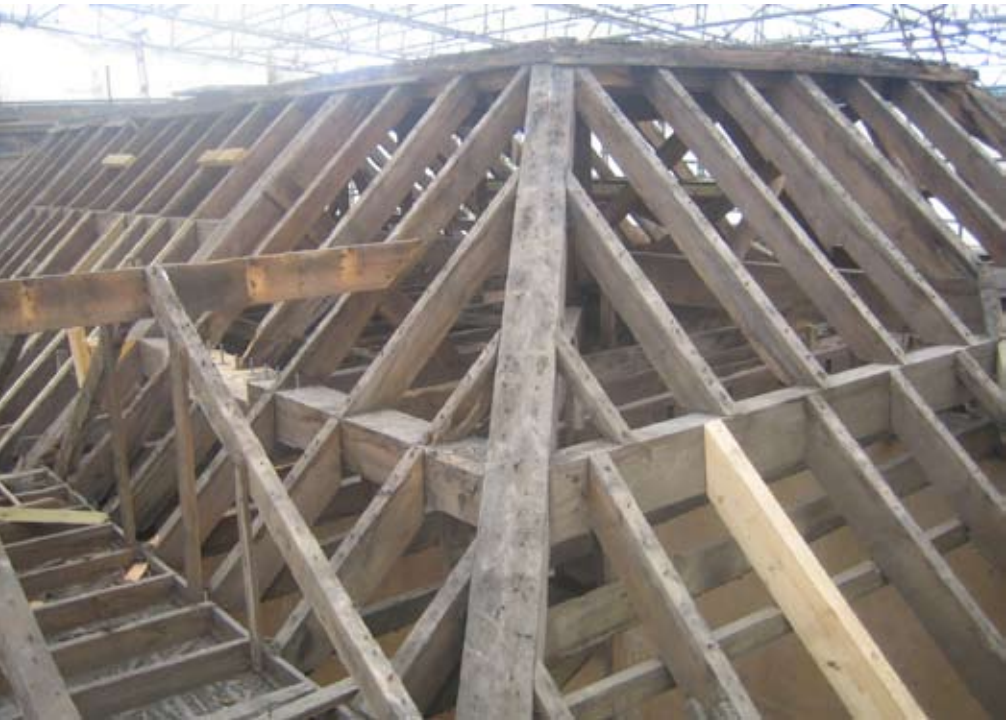
A roof of the Late 18th under repair, showing the purlins midway in the span.

In some earlier roofs, the A-frames are fewer, and joined longitudinally by timbers called purlins, shorter and smaller rafters then carry the roof. As the rafters have to carry more weight, they are referred to as principal rafters. This type of roof became rare by the 19th C, and standard A frame

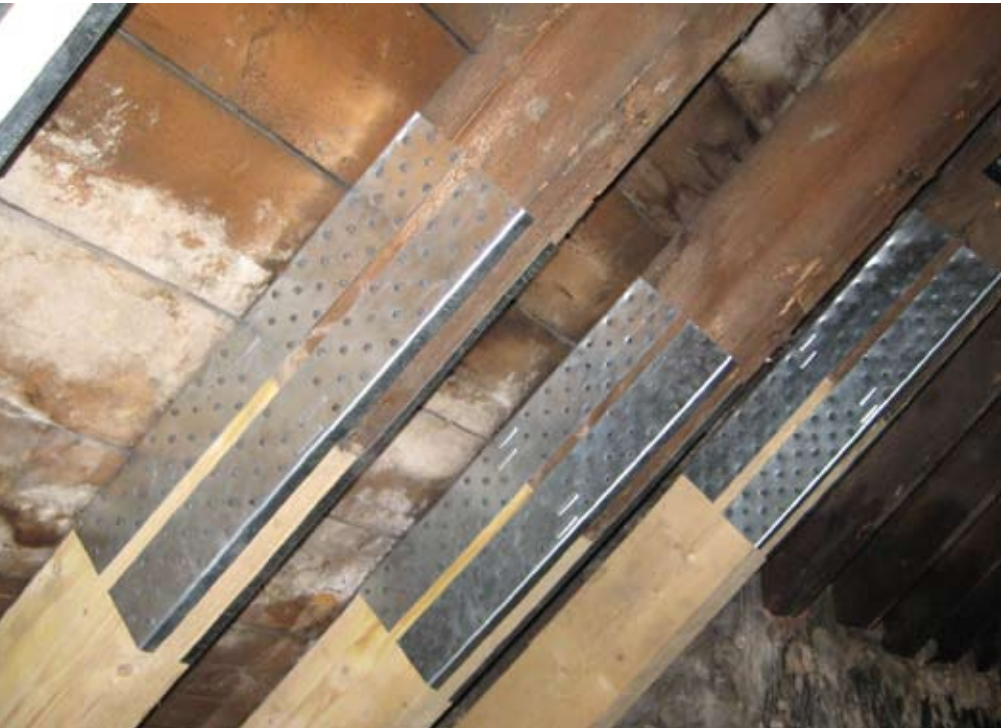
Modern metal pre drilled straps used in rafter splices.

Plating using modern steel is a similar approach, but using preformed steel plates, angled to fit the joist. They are fixed with ringshank nails. This repair is simple and

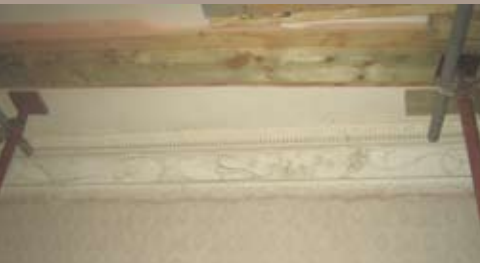
Supporting a ceiling during work on the joist ends

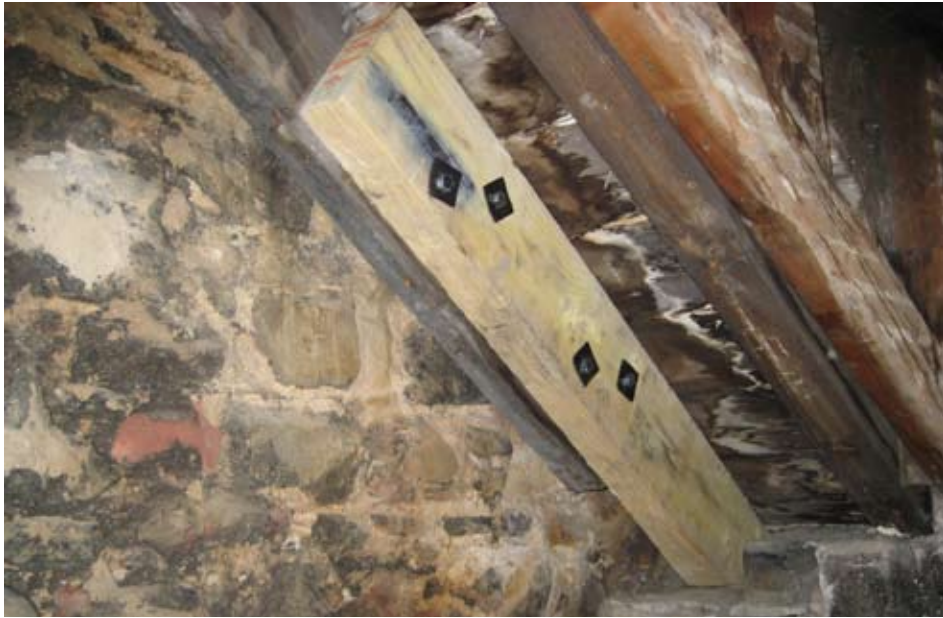
Strengthening of the joint with bolts

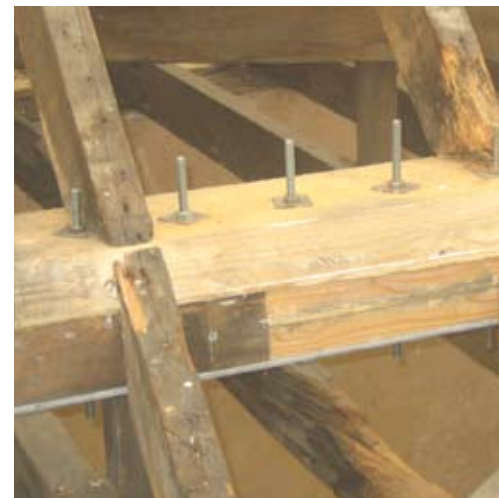
Composite repair using resin, new timber and steel plate

Resins and glues. Some engineers specify an epoxy resin to be used in structural repairs, especially in areas where the thrust is in more than one plane of the timber element (for

example valley beams). Such resin is normally a slow setting resin, giving time for the resin to soak into the matrix and fibres of the timber.
