## 16.0 Management/restoration of particular features

## 17.0 Traditional materials

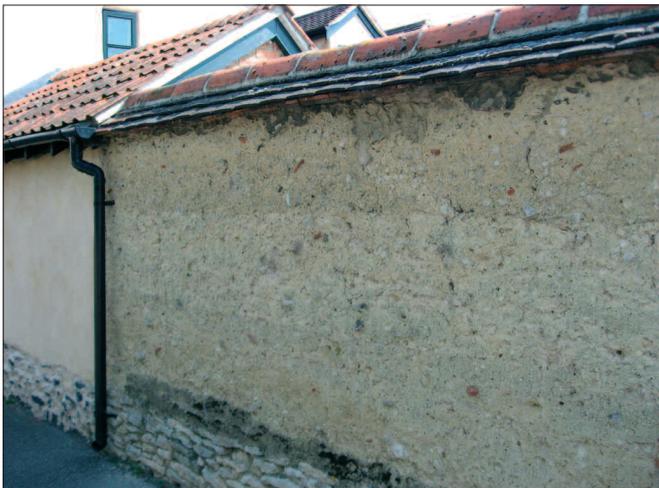
55. Unrendered cob and witchert walls are part of the character of some areas within the district. These are often mistakenly rendered. If the incorrect materials (cement based render) are used this can have disastrous results.

and in some cases painted. These walls in many cases were left unrendered and this is part of the character of the walls (Figure 55). Stone and brick walls are also a strong characteristic of some parts of the district. Stewkley is a good example of where boundary walls play an important role in the character and appearance of the conservation area (see Stewkley Conservation Area Appraisal – Jan 2001). These are also suffering from poor maintenance with some losing capping details and flint panelling and some being the subject of poor repointing work which has damaged the character of the wall as well as potentially leading to their failure.

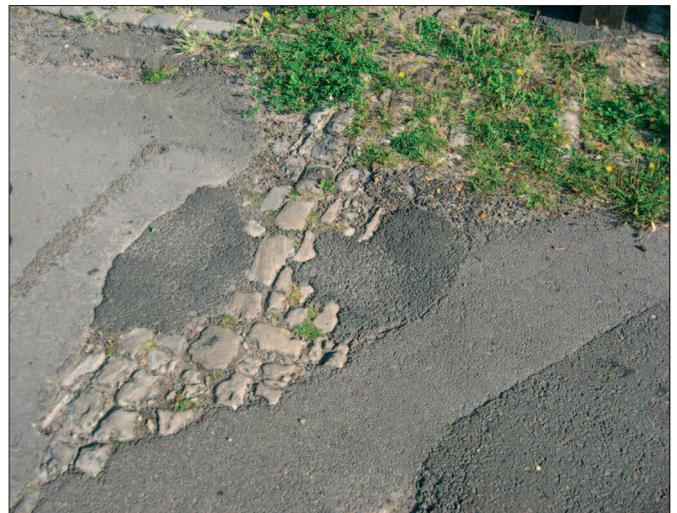
56. The covering over with modern tarmac and poor repair of historic street surfaces and finishes in Aylesbury significantly erode the special character of parts of the conservation area.

**16.2.4** The loss of historic surfaces and their replacement with areas of tarmac is a very significant issue, particularly evident in Aylesbury but seen in almost all of the sample survey settlements (Figure 56). In addition, the repair and maintenance of surfaces; broken, cracked and missing pavers and particularly poor or inappropriate repairs, especially after utilities have been installed, is a major issue in the towns but is also seen in the smaller settlements (Figure 57).

**16.3.3** An audit of historic street surfaces should be undertaken for all conservation areas. Historic survival should be noted on an appropriately scaled map and recommendations for reinstatement highlighted where appropriate.

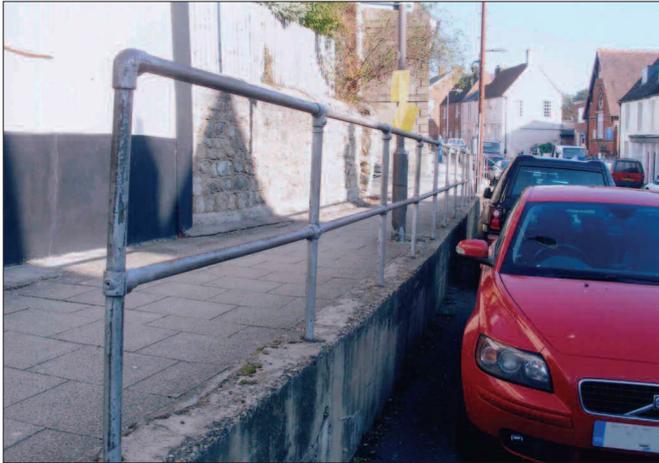
57. Poor quality materials in the public realm (Buckingham)

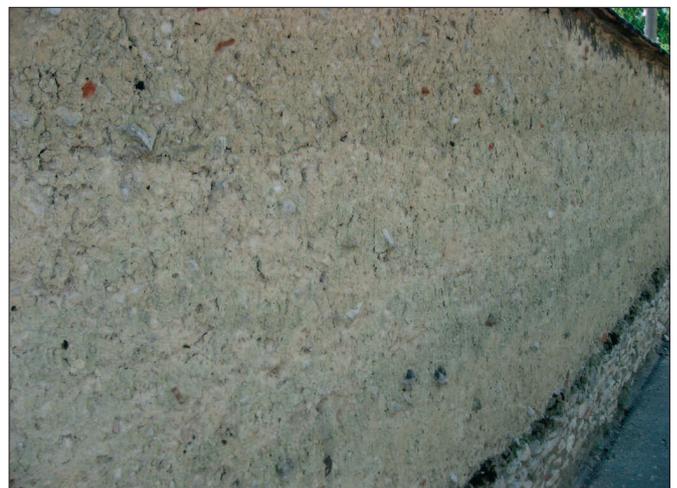
stone or stone rubble is known as the grumplings and the lifts of materials (with walls often containing horizontal bands illustrating the number of lifts – Figure 58) are known as ‘berries’. The cappings are usually clay tiles but thatch was once common.

58. The witchert (and cob) walls of the district are constructed in lifts known as ‘berries’. These lifts can often be made out as subtle variations in colour and texture denote the next lift. This is a key characteristic of this building type.

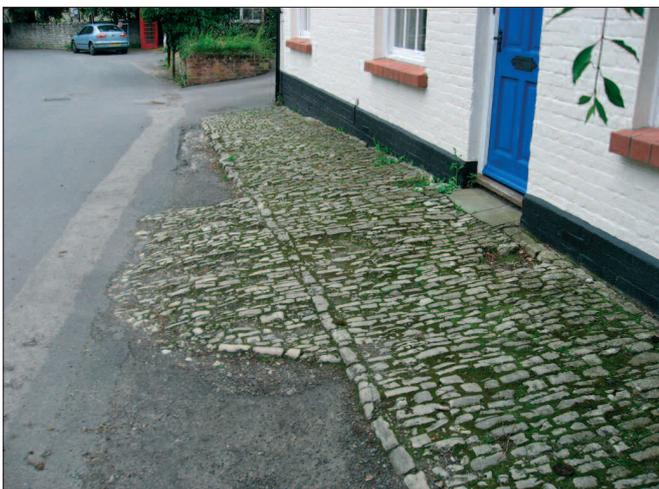
**17.2.5** An often over-looked aspect of local materials is the traditional paving treatments which are rich and varied across the district. The latter also has remnant sections of river washed cobbles to some parts of the town. In Cuddington for example (along with a number of other villages notably Haddenham), areas of stone setts forming historic pavements survive (Figure 59). Long Crendon (not part of the sample survey) has a strong traditional palette of stone setts to cross-overs (Figure 60). Survivals of stone setts are also seen in Brill (Figure 61) and other settlements such as Buckingham.

59. Survival of historic pavements in Cuddington.

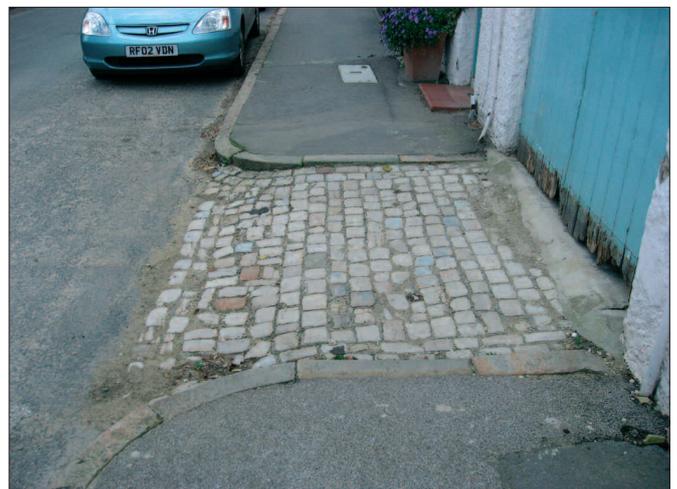
60. Stone setts to pavement cross-overs in Long Crendon.

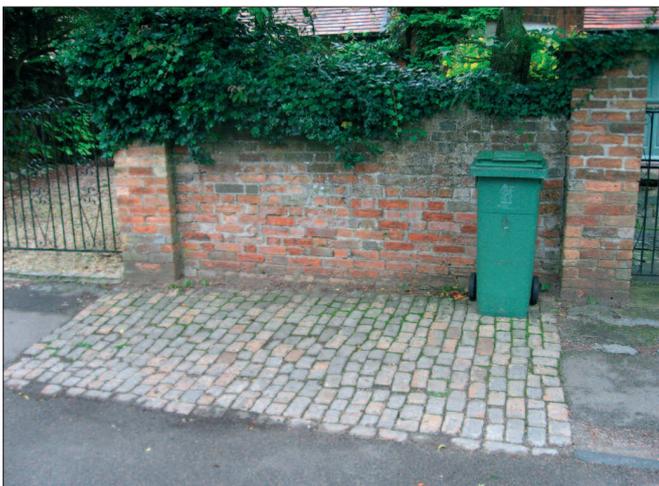
61. Survival of stone setts in Brill.

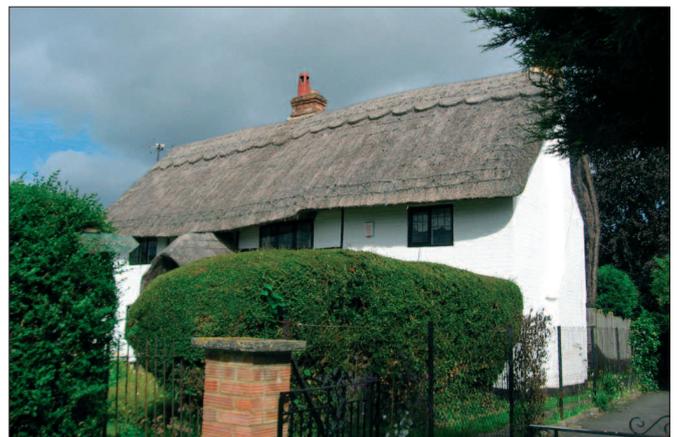
**17.2.6** The thatching tradition of the Aylesbury Vale is being significantly eroded through inappropriate replacement of traditional straw coats with water reed. The replacement of traditional flush wrapover ridges with untraditional block cut ridges is also a major issue

throughout the district. This was evident in the sample settlements, particularly Weston Turville where all of the ridges were block cut albeit with fairly simple patterns (Figure 62).

62. Block cut ridges on straw roofs forms the predominant thatch finish in Weston Turville (the hybrid thatch – thatching advisory guide, AVDC)
