# Short Guide

Information for Traditional Building Owners

## Sash & Case Windows

A short guide  
for homeowners

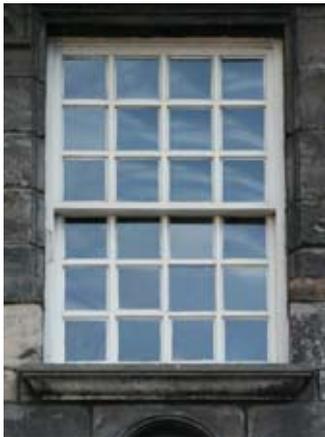
An early sash and case window with thick astragals

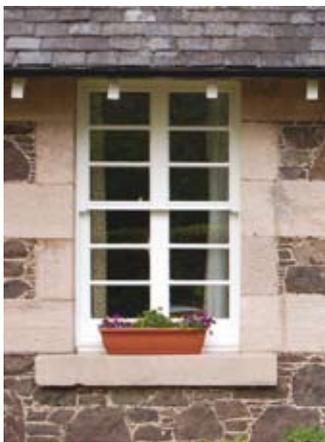
Early 19th Century lying panes

In the early nineteenth century, whilst the Georgian pattern continued to be used, horizontally proportioned panes called lying panes were also popular. Occasionally margin panes were used in buildings of this period, an arrangement which continued to be used for stair windows long afterwards.

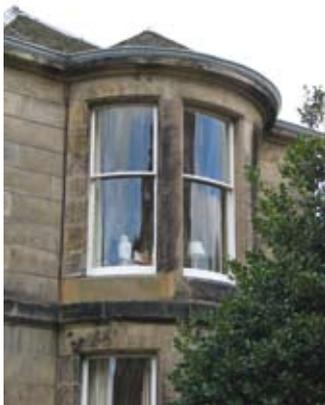
A fine example of 19th Century curved sash frames and glass

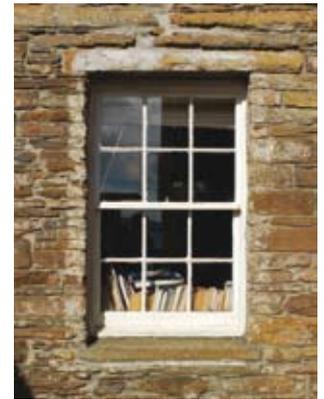
A Georgian sash and case window

In the eighteenth century, larger pane sizes and slimmer sash members became feasible. By the middle of the century the familiar Georgian window with 6 panes to each sash had become commonplace. Better quality crown glass was used to glaze these windows, recognisable by its distinctive curved ripples and the slight bellied effect often visible in individual panes when viewed in sunlight. True crown glass is no longer made, making it all the more important to keep any historic crown glass found.

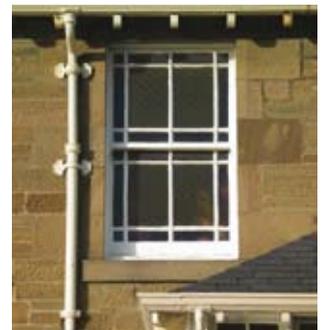
19th Century windows with margin panes

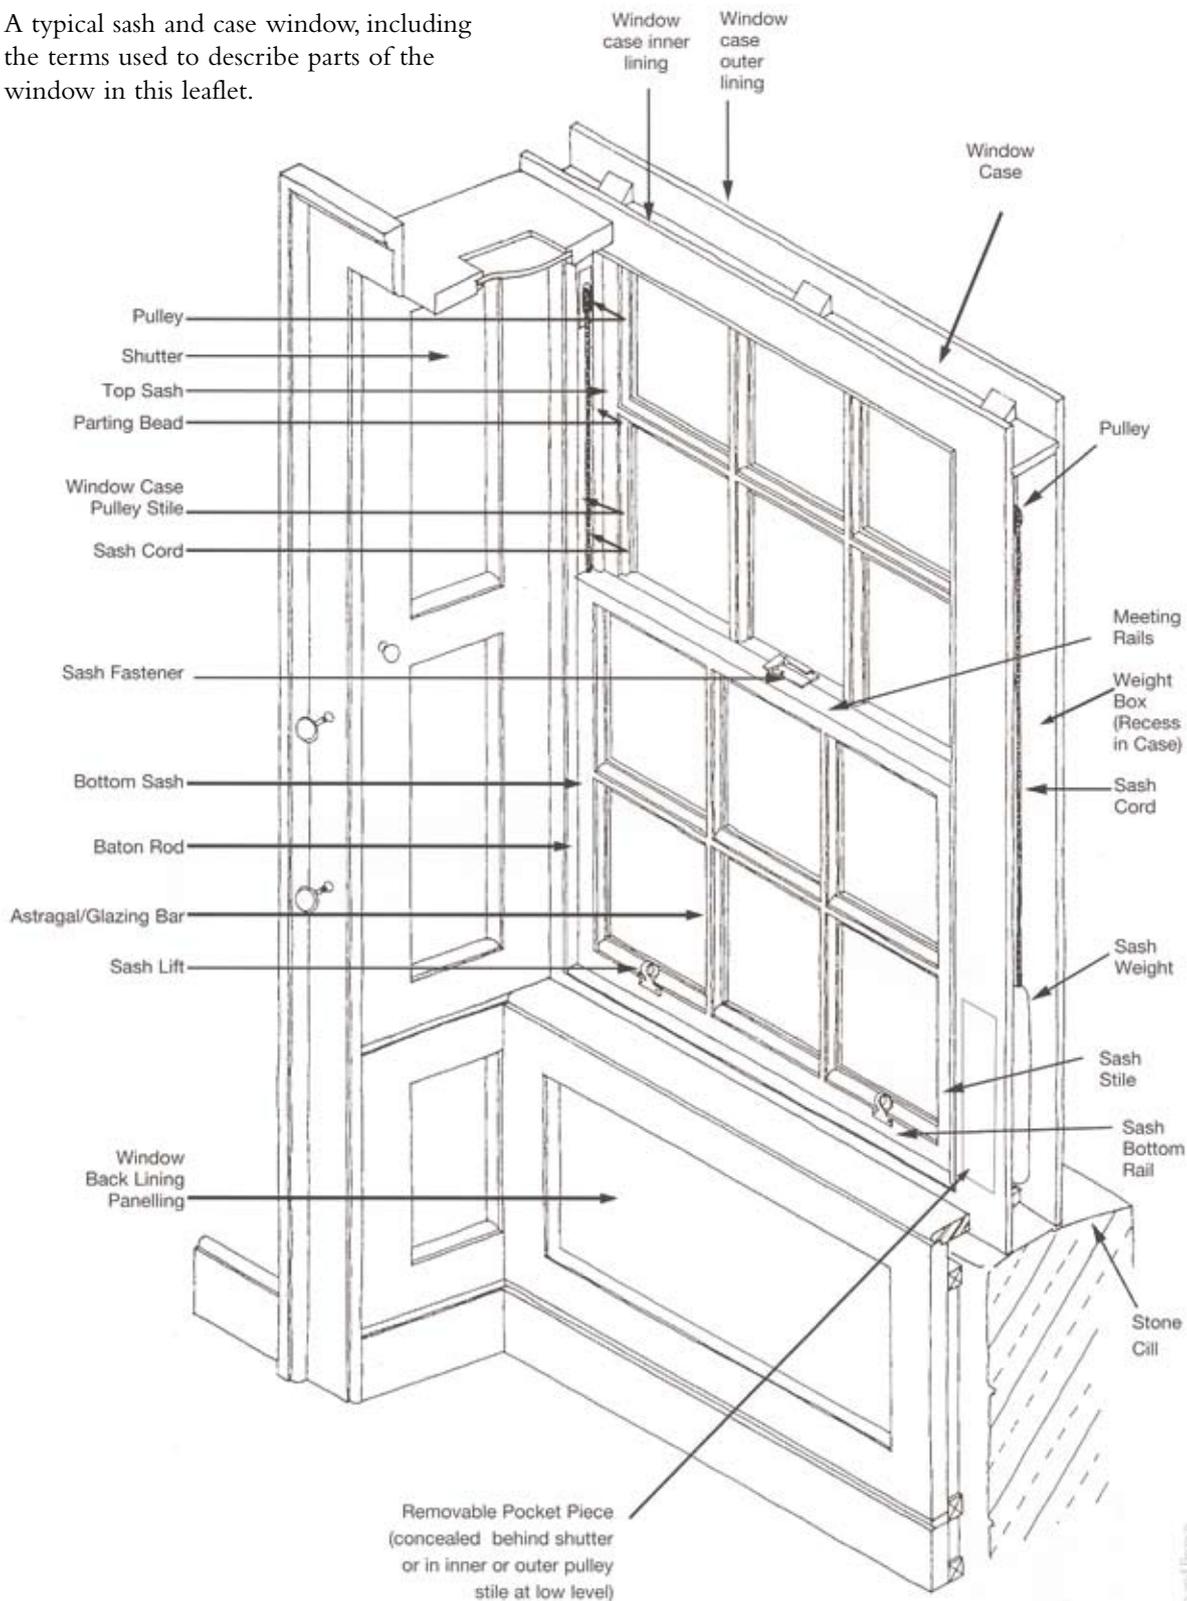
A typical sash and case window, including the terms used to describe parts of the window in this leaflet.

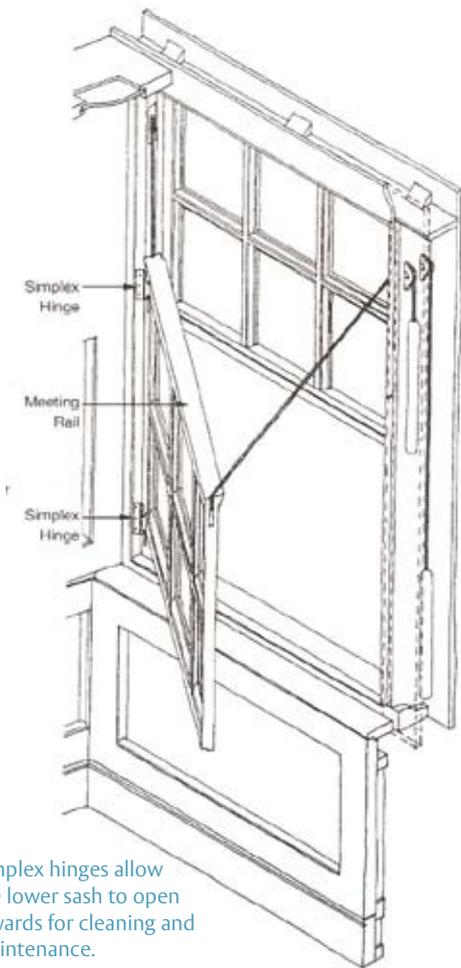
Simplex hinges allow the lower sash to open inwards for cleaning and maintenance.

The lower sashes of many traditional sash and case windows are fitted with the ‘Simplex’ hinge system. If so, then both inner and outer faces of the sash can be cleaned from within the building. If not fitted, you should consider installing Simplex hinges to make cleaning easier.

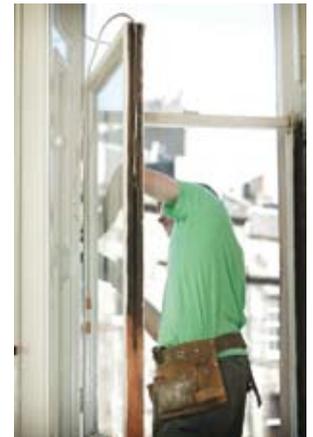
The Simplex hinge system in operation

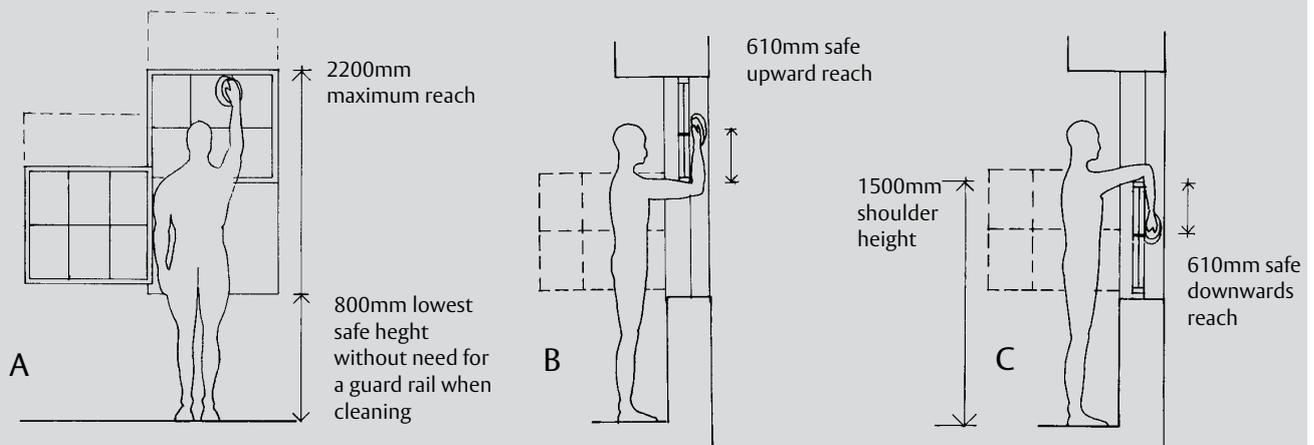
Diagrams showing how sash and case windows may be safely cleaned, following guidelines in BS8213

The lower sash is swung inwards on Simplex hinges so that its outside face can be cleaned. With the lower sash swung in, the top sash is moved down so that all of its inside face can be reached (A). The top sash's position is then adjusted so that the lower part of its outside face can be cleaned (B) and then fully dropped to enable the remaining upper part of the top sash's outside face to be cleaned (C).

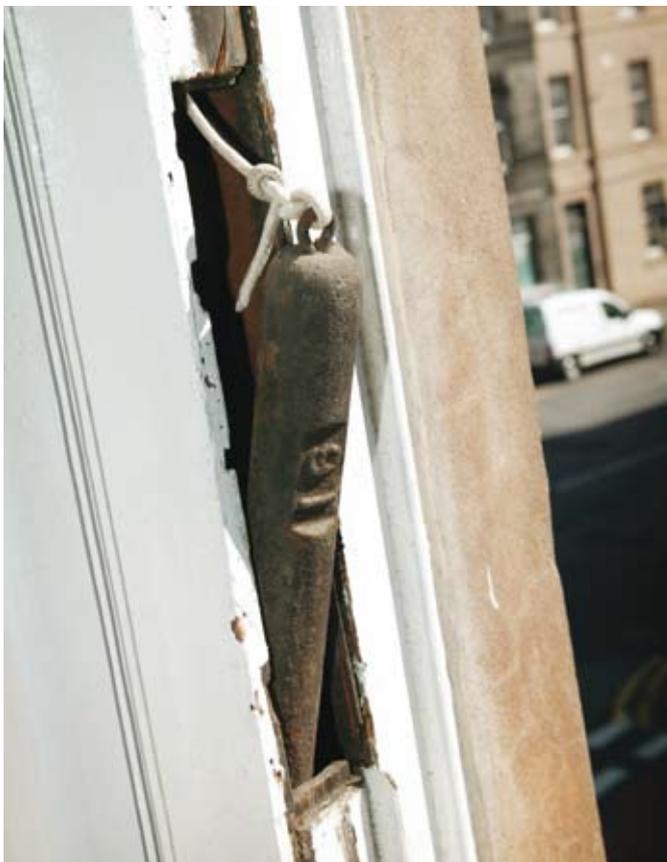
The sash weight can be seen here where the pocket piece has been removed to expose the interior of the window case.

The majority of window sashes are counterweighted so that they can be operated easily. Sashes are hung on cords which pass over pulleys and connect to weights concealed within the weight boxes in the hollow sides of the case. These cords require replacement when worn or broken. In larger heavier windows, chains were often used instead of cords and should be retained and refurbished as necessary.

- ❑ the weight box ‘pocket piece’ cover adjacent to the damaged rope is removed to give access for retrieving the sash weight from the bottom of the case and to allow clearing out of any accumulated debris from inside the weight box.

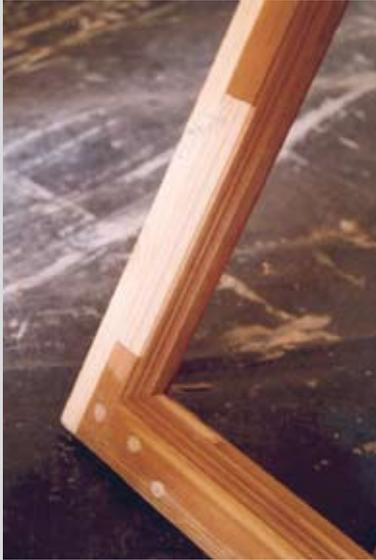
**Pieced in section of timber to stile**  
Note the grain density and direction of original and new timber in photo. Replacement timber should be selected to match the existing timber as closely as possible - otherwise the new and old timbers may shrink and expand at different rates causing gaps to open up in otherwise sound repairs.

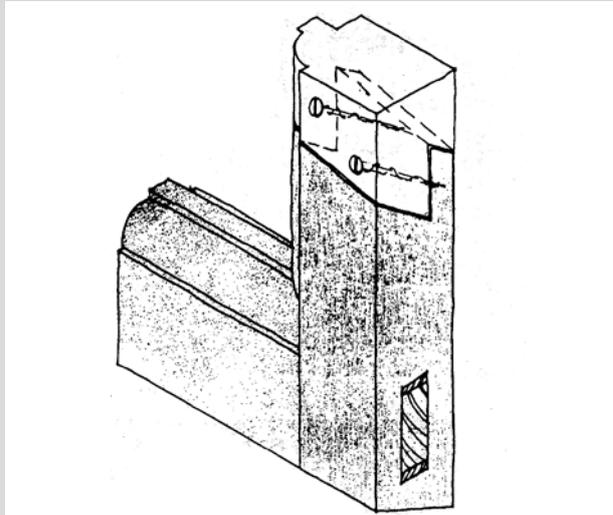
Replacement of bottom rail and base of sash stile.

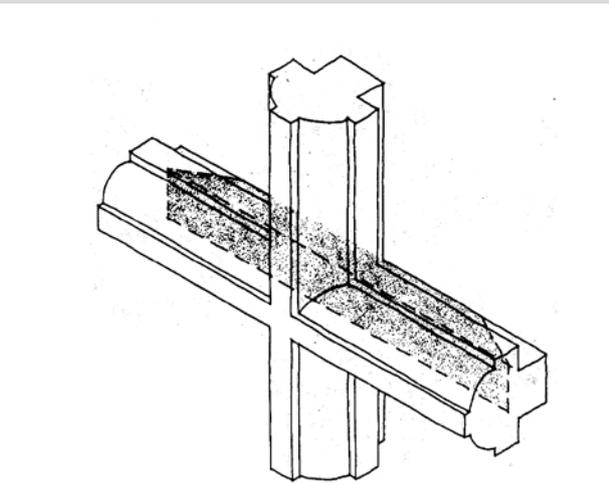
Replacement of tongue of astragal at junction of astragals.

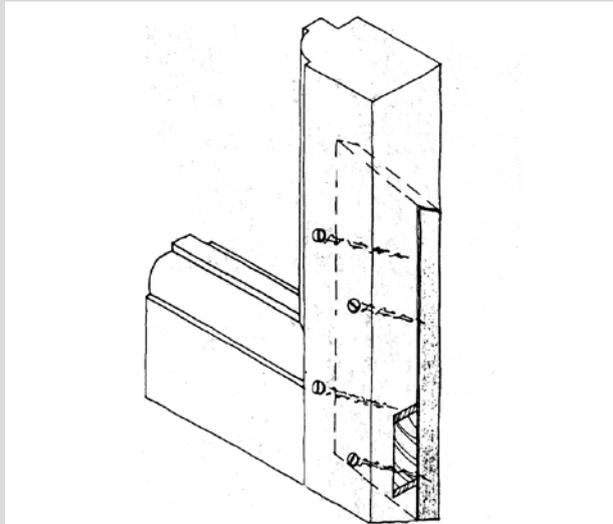
Replacement of base of outer face of sash stile.

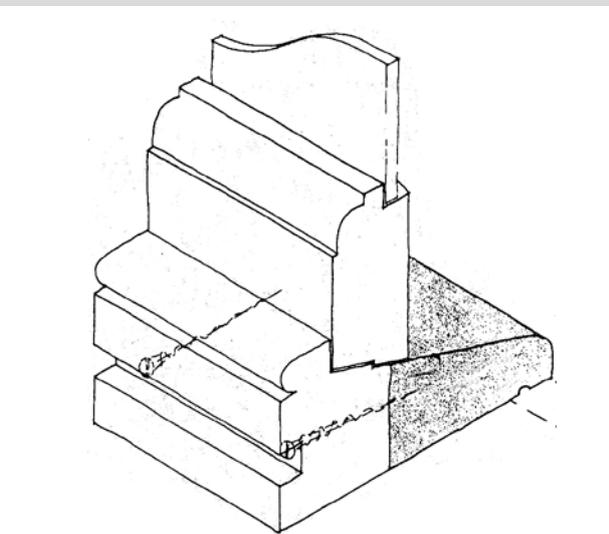
Replacement of half cill.

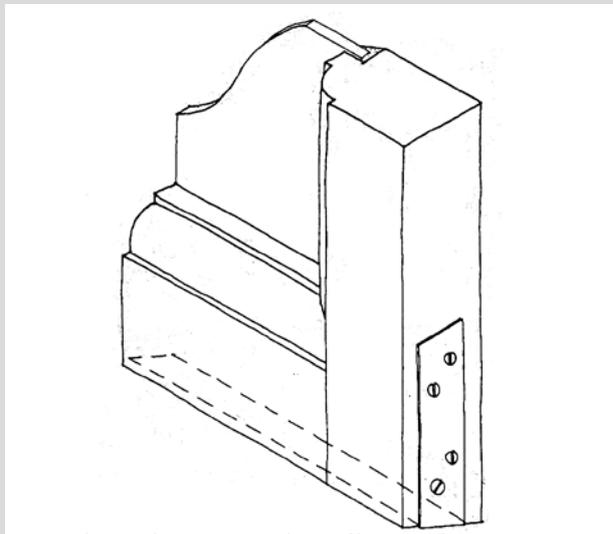
Strengthening loose joints at base of lower sash.

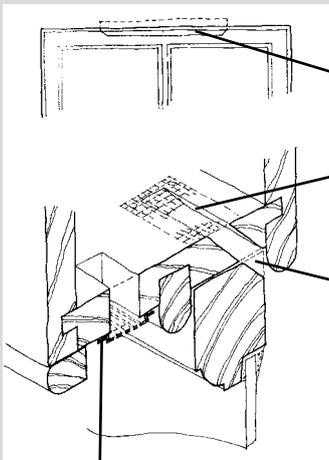
Chamfered termination to slot in top sash

Insect mesh fixed

Allows ventilation through resulting gap between meeting rails even when window is closed

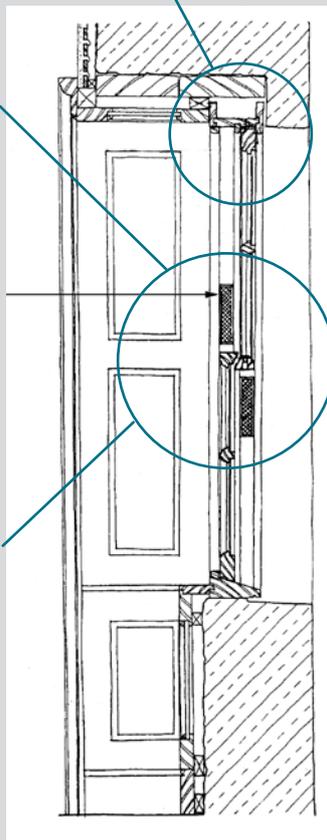
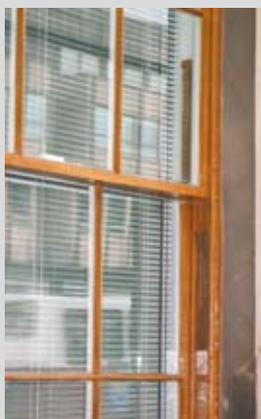
method of providing background ventilation through window pulley stiles

Slots cut in both the inner and outer section of the pulley stile and insect mesh and grilles fitted.
