Energy Efficiency and Historic Buildings

Insulating timber-framed walls

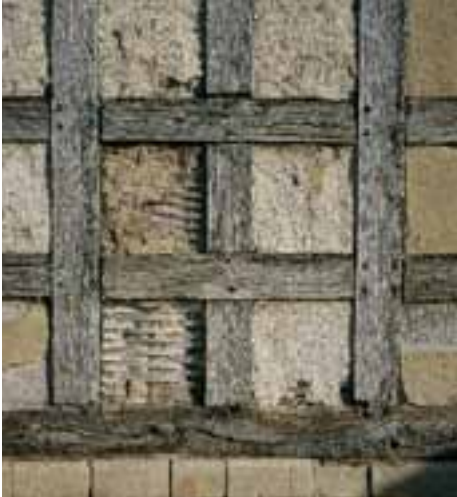
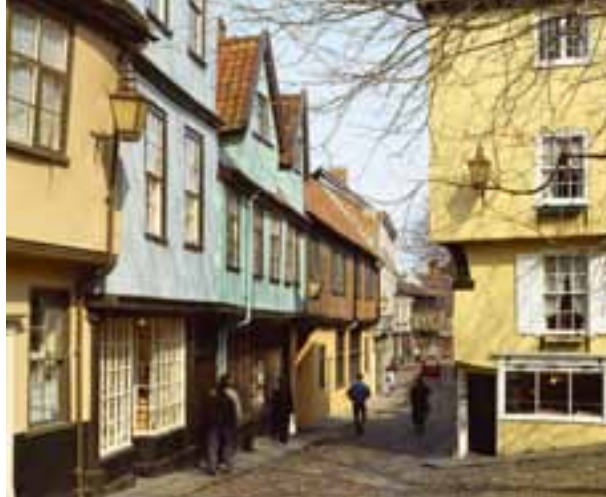
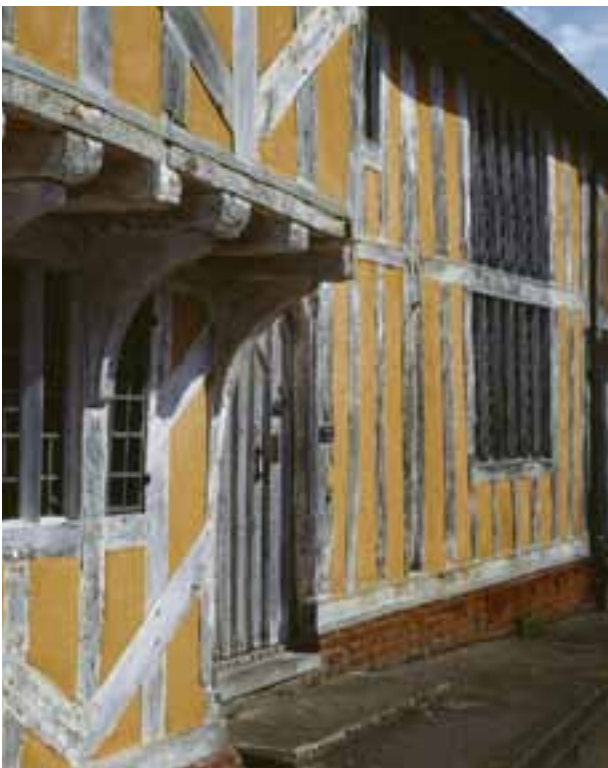
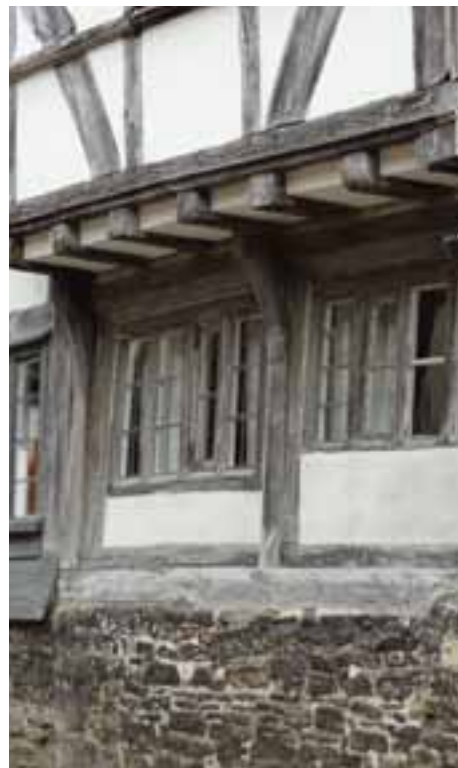
01/02/03/04 There are many variations in the construction of timber framed buildings resulting in a wide variety of thermal performance. All images © English Heritage photo library except bottom right © EH/David Pickles

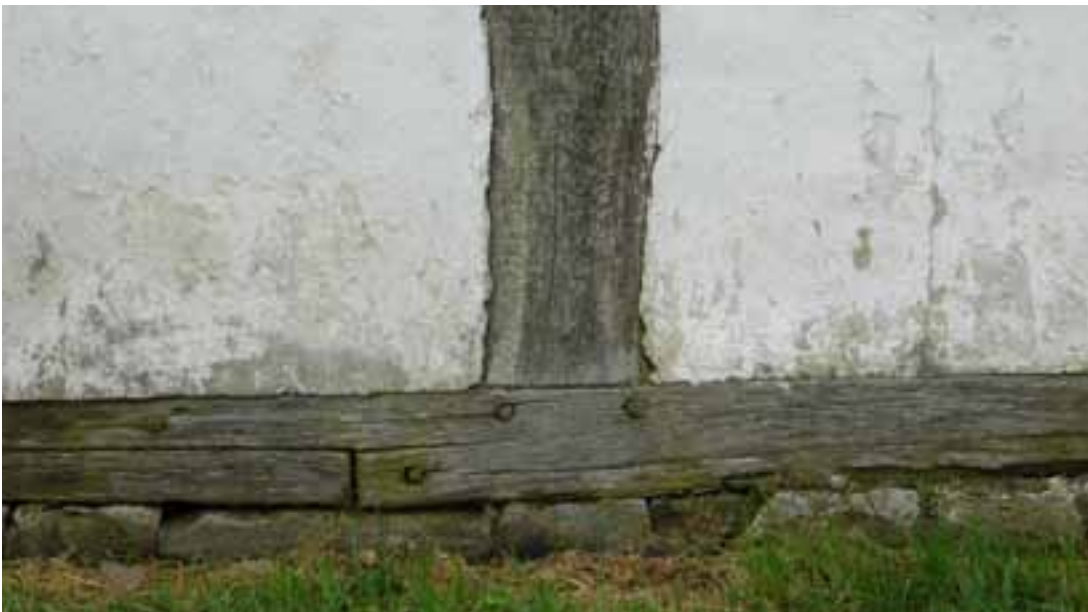
05 The most vulnerable part of the timer frame to damp is the lowest horizontal timber the sill beam or sole plate as this is the timber nearest the damp ground. © EH/David Pickles

Timber framed buildings were normally constructed with the lowest horizontal timber (the sill beam or sill plate) resting on a masonry plinth wall. One of the functions of this wall was to isolate the timber frame from the damp ground. This was possible without a damp-proof course by allowing the maximum of evaporation from the surface of the permeable plinth material.

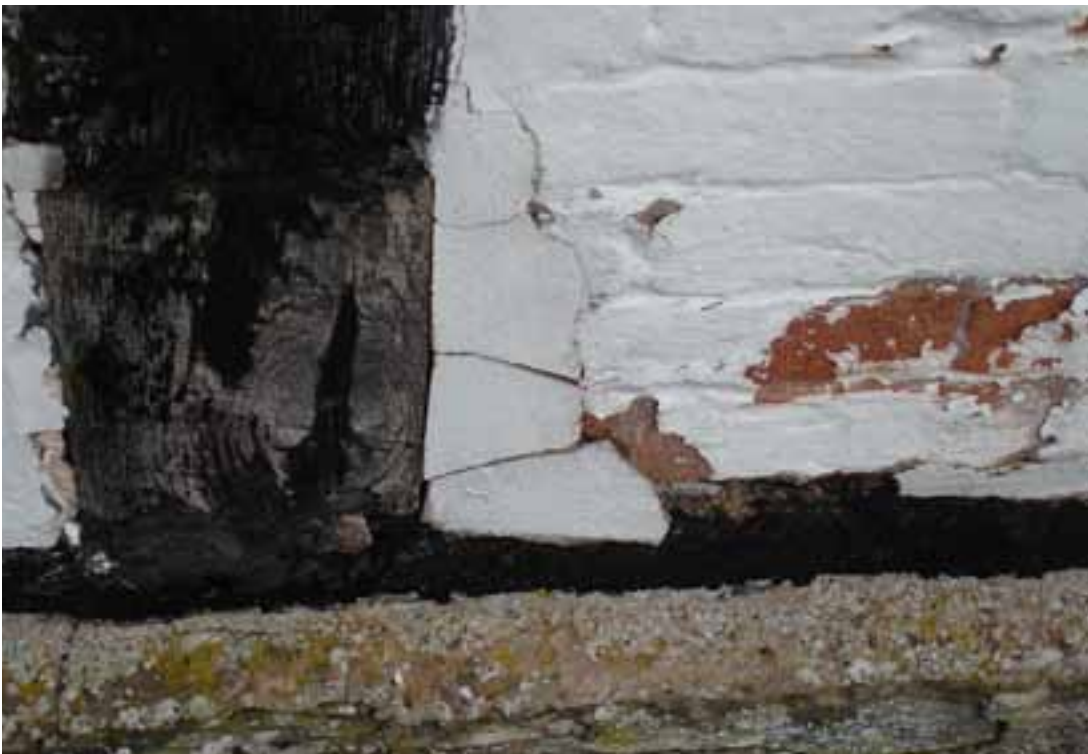
06 A hard cement mortar has been used to fill the gap at the edge of a brick panel. As the mortar is inflexible it has cracked and will trap moisture against the frame possibly leading to decay. © EH/David Pickles

The most damaging decay to a timber-framed building is usually found where inappropriate materials have been used to repair the building. The introduction of impermeable materials, such as cement-based renders and modern paints, will significantly increase the risk of water trapped within the fabric and prolonged dampness will cause decay. Decay in the timbers of a historic timber-framed building is not only an aesthetic problem; it can result in the loss of structural integrity.

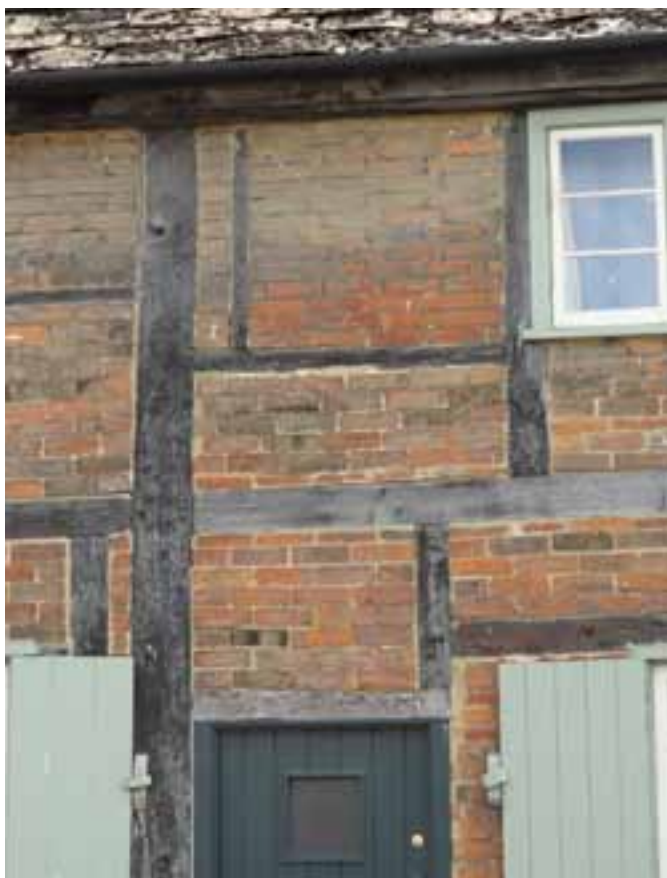
07 A timber framed cottage with brick infill panels. © EH/David Pickles

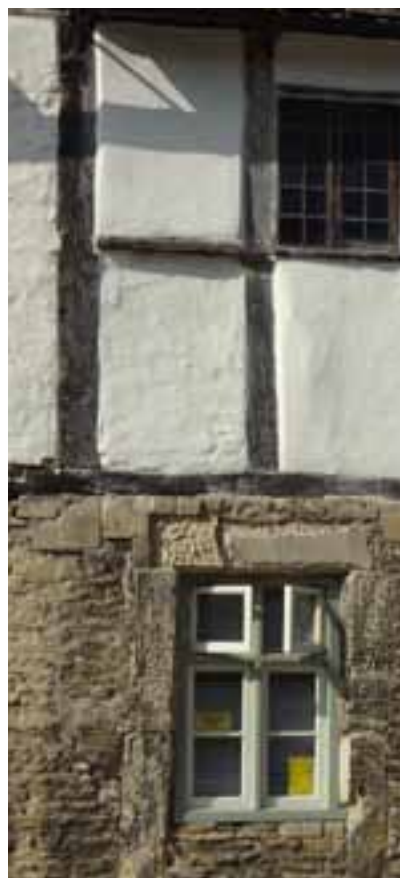
08 A timber frame above a stone ground floor. © EH/David Pickles

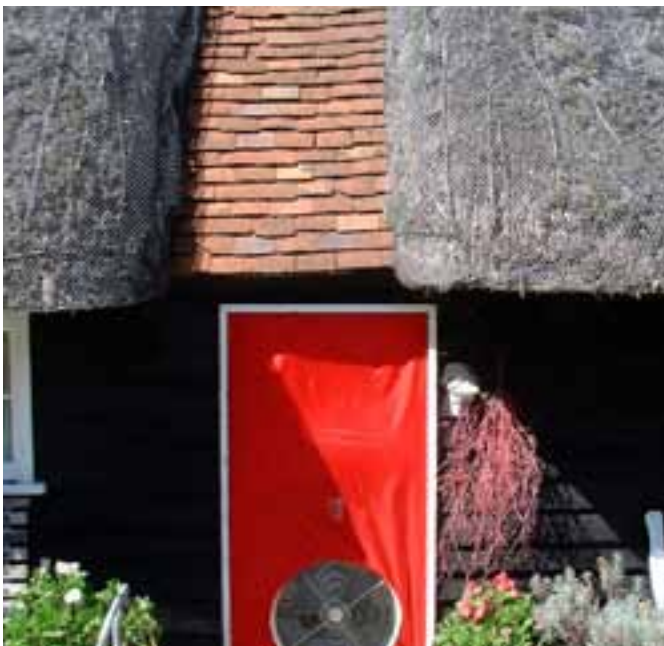
09 Pressure testing a timber framed building can give a good indication of where there is excessive air infiltration. Such areas can then be targeted in any planned thermal upgrading. © Oxley conservation

One of the characteristics of timber-framed buildings is that there can be a high number of cracks and gaps in the construction, particularly between the timber frame and infill panels. Some of these sources of draughts will be obvious to a visual inspection (chinks of light) or to an occupant on a cold windy day feeling the draughts. However, a more thorough and far more effective way to identify all the cracks and gaps will be to carry out an air pressure test.

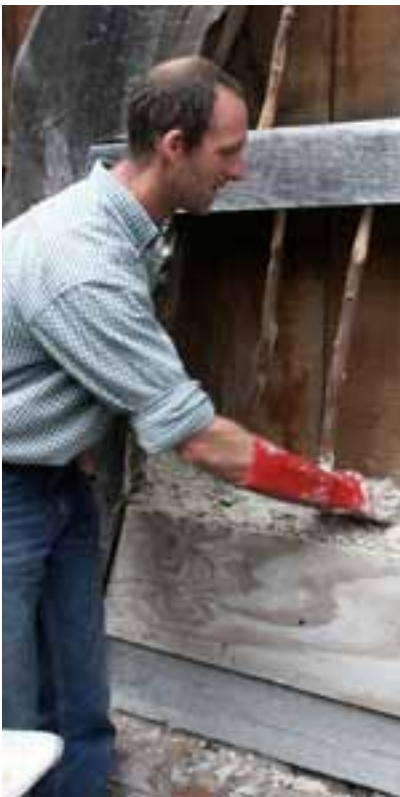
I0 Hemp-lime being installed as an infill panel. © EH/Iain McCaig

Hemp lime composite materials have been successful in France and more recently in the UK and Ireland in providing compatible insulation which can infill timber frames. The material has also been successful in meeting very demanding thermal performance targets in new buildings. The material is based on chopped hemp 'shiv' (the remains of the woody stem of the plant) mixed with specially developed lime based binders. It can be mixed conveniently on site to give a lightweight 'concrete' or 'hempcrete' containing a great deal of air. It is then finished externally and internally with lime renders, cladding or clay plasters.

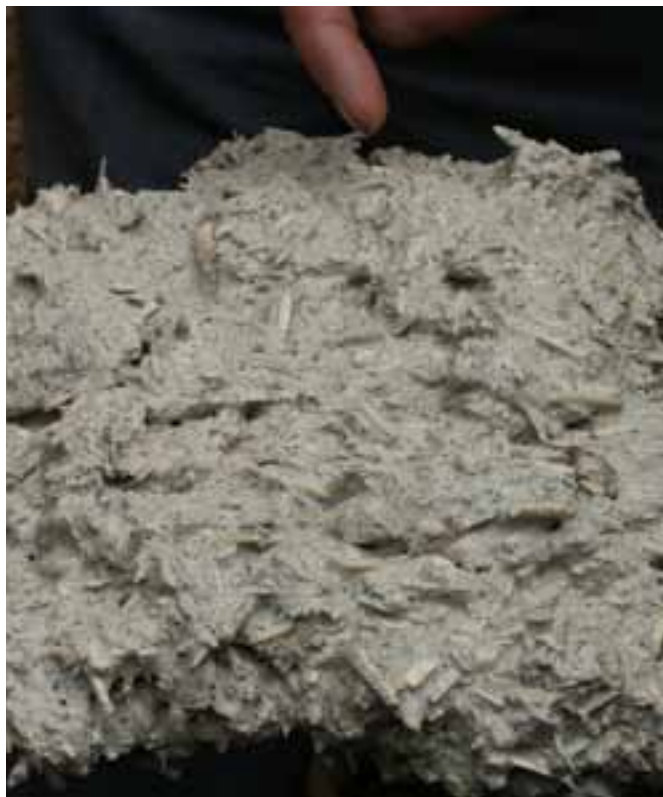
I1 Hemp-lime is a mix of chopped hemp mixed with a lime based binder. © EH/Iain McCaig

The resulting material is a rigid cast insulation which can accommodate a certain amount of movement in the timber frame and which is highly compatible with the moisture behaviour of the timber itself. It also has inherent thermal mass and can therefore help to dampen out the internal temperature fluctuations which can be such a problem in lightweight construction (typically 10mm or so), or it can be cast to a greater thickness if the opportunity arises.

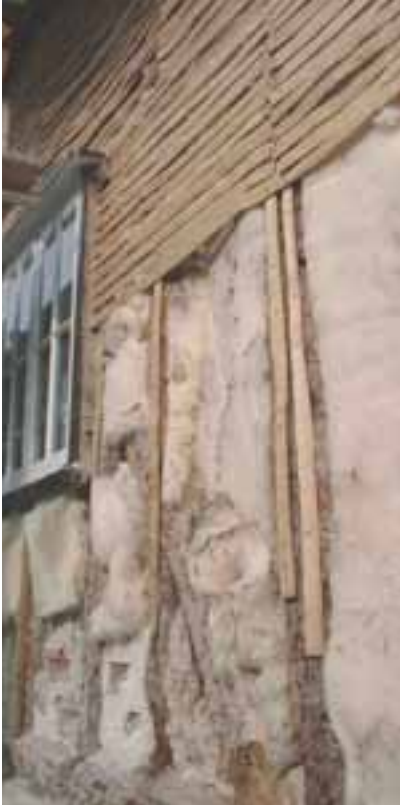
12 Timber laths being added over a frame to take an external lime render. Sheep's wool insulation has been added between the frame. © Oxley conservation

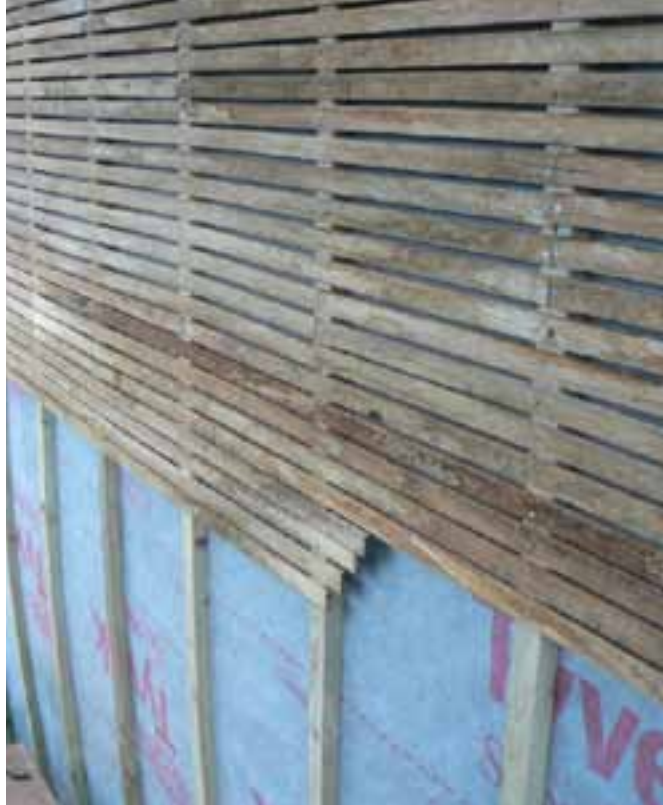
13 Timber laths being fixed externally over a vapour permeable membrane .
© Oxley conservation

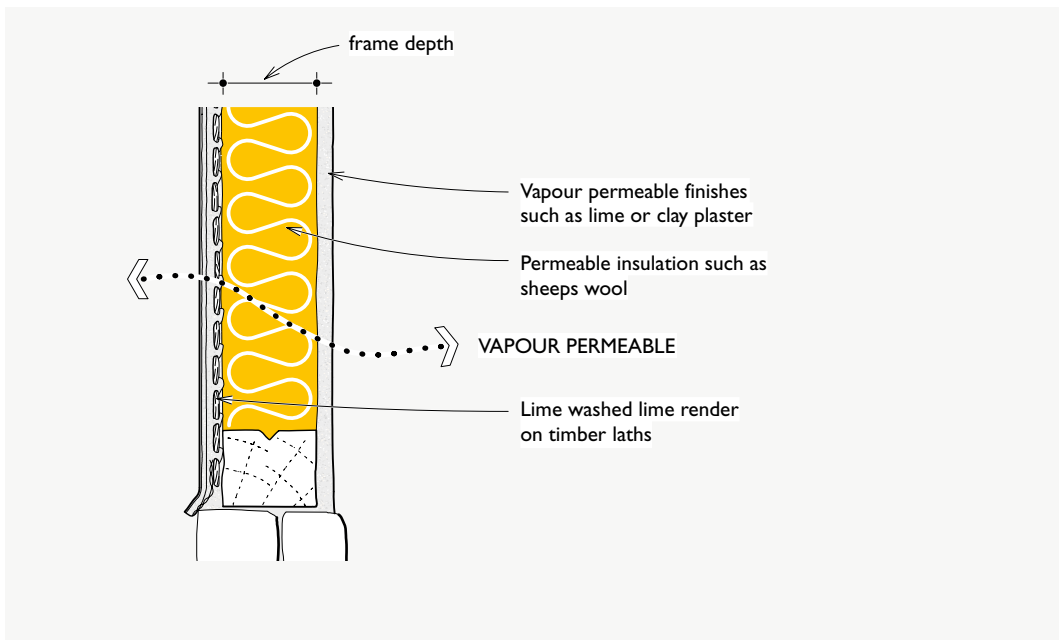
INSULATION WITHIN DEPTH OF FRAME

14 Permeable insulation is shown here placed within the frame which is covered on the inside and outside with a lime render. Insulation materials such as hemp-lime, wood-fibre or sheep's wool could be considered. Such work could be carried out from the inside if the external lime render is to be retained.

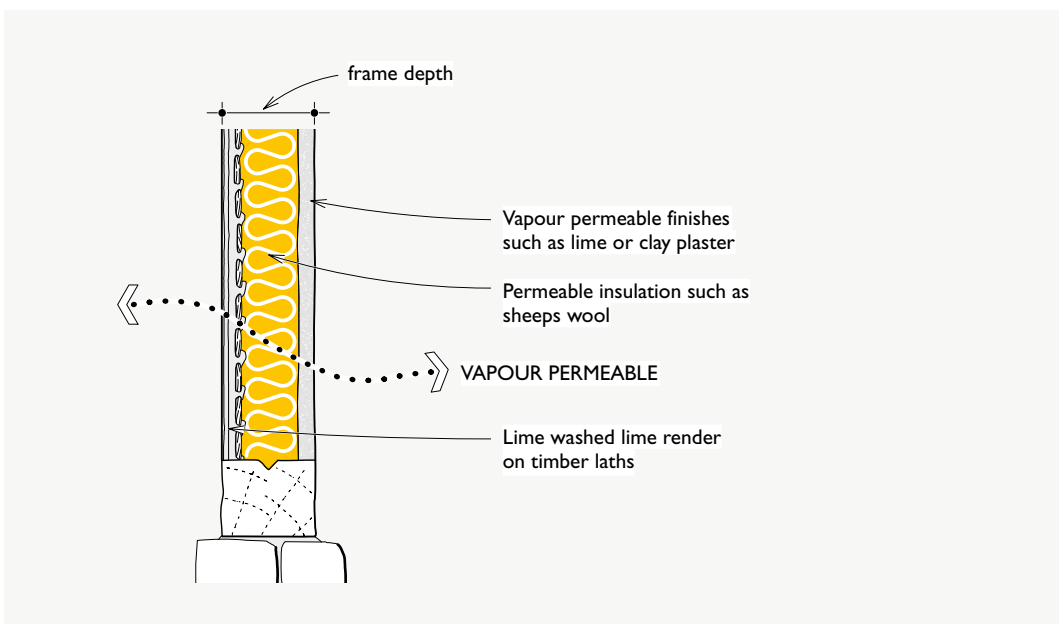
INSULATION WITHIN DEPTH OF FRAME

15 Permeable insulation is shown here within the depth of the frame which is exposed both externally and internally. This form of construction creates the problem of maintaining an airtight junction between the infill panel and the timber frame. The thermal efficiency in this situation will never match a frame that is covered.

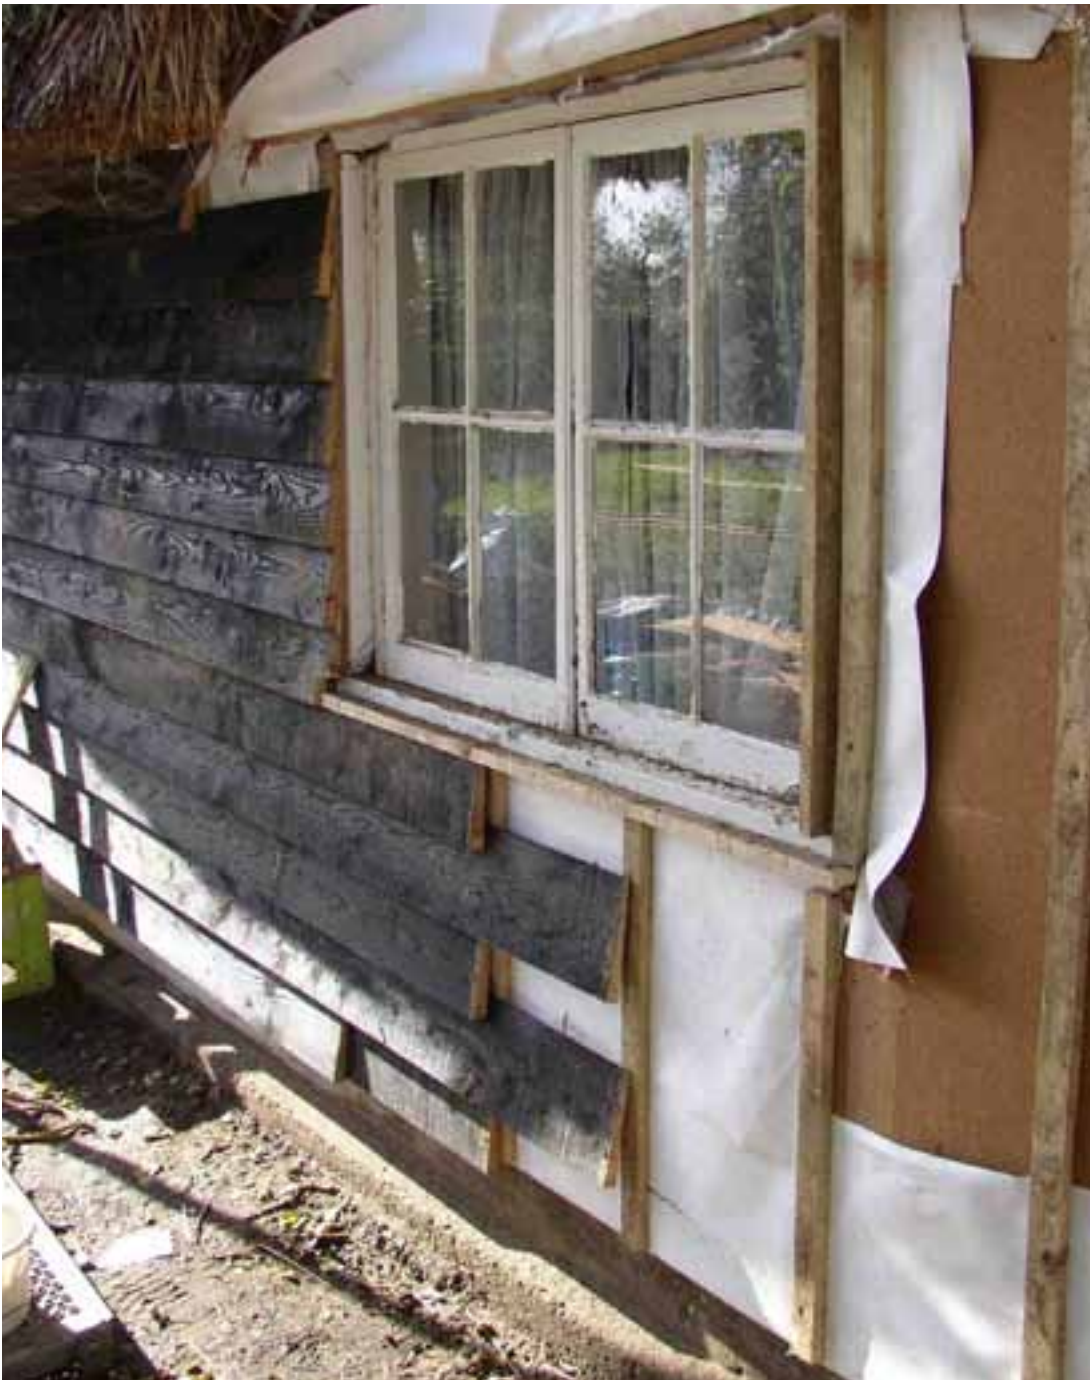
16 A vapour permeable membrane and tongue and grooved wood-fibre board has been added onto the frame below weatherboarding. © Oxley conservation

The removal of tile-hanging or weatherboarding for repair will also provide an opportunity to install insulation within the thickness of the timber frame. Cladding can be relatively easily removed and in the case of tile or slate hanging can normally be re-used. The removal of weatherboarding is more difficult without causing damage particularly if any rot has occurred. Reinstatement of the cladding over a vapour permeable 'breather membrane' added as a secondary barrier behind the cladding can significantly improve the performance and effectiveness of the insulation by reducing air infiltration. The breather membrane should be installed with some 'slack' behind the cladding, in particular when used with weatherboarding, so that it is not held tight to its' back face. This will allow any water that penetrates the cladding to run freely away down the face of the membrane without being redirected against the timber cladding.

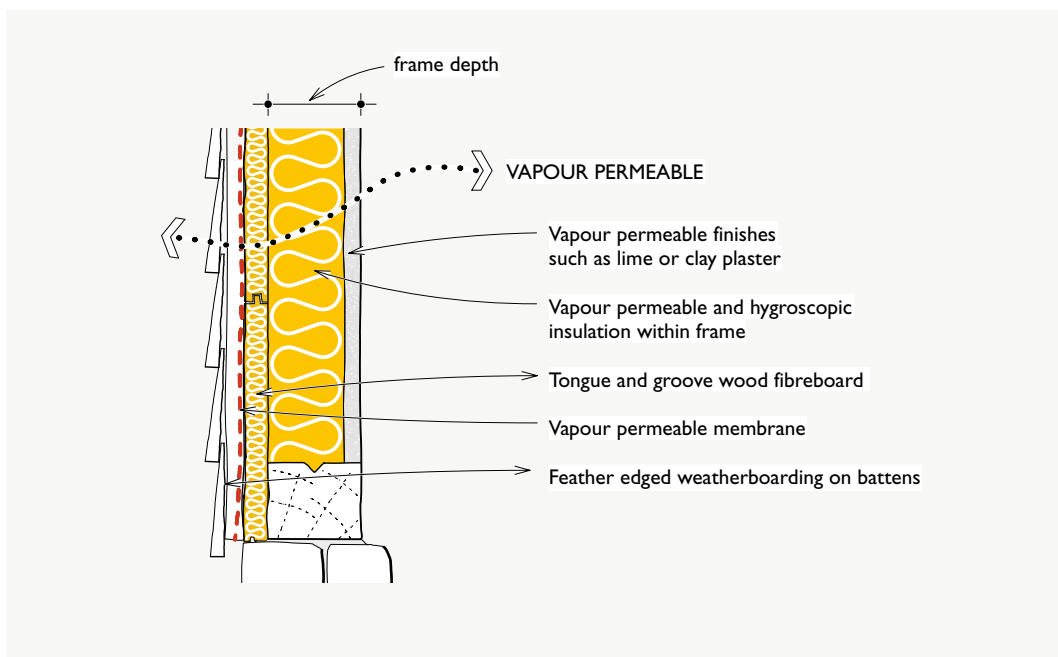
INSULATION ADDED BEHIND WEATHERBOARDING AND BETWEEN FRAME

17 If weatherboarding or tile hanging needs repair or renewal then this can provide an opportunity for insulating both between the frame and to the face of the frame below the weatherboarding or tile hanging.

External insulation is the most effective means of insulating a timber-framed wall. It can be achieved by fitting wood fibre or other similar boards over the external face of the timber frame, taking care to seal any gaps between boards caused by the unevenness of the frame beneath. The disadvantage of such boards is that their fitting will change the position of the cladding, making the wall thicker. This will require consequential changes in window reveals, eaves projections, rainwater goods locations and other façade details that are costly to make and could have a material, possibly unacceptable, impact on the appearance of the building. Wood-fibre boards are available that are impregnated with latex. Such boards can act as a secondary barrier to any rain driven through the cladding. Other boards may require the provision of a vapour permeable felt to protect them from driven rain.
