INFORM

INFORMATION FOR TRADITIONAL BUILDING OWNERS

Bituminous Sheet Flat Roofs: Their repair and maintenance

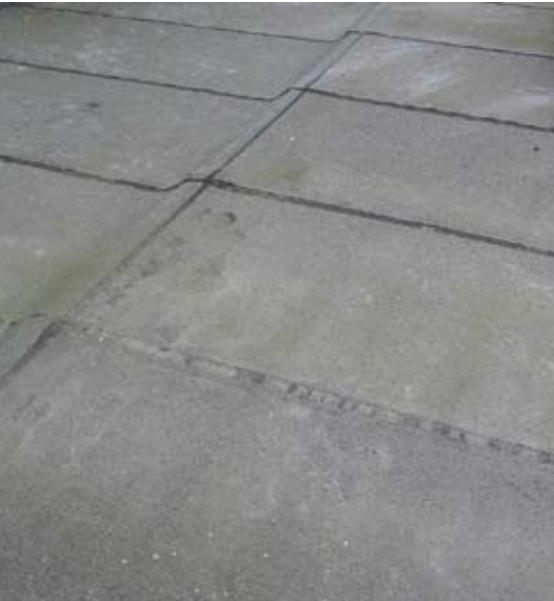
Flat roof covered in sheets of bituminous felt

Flat roofs basically consist of joists, sarking and a waterproof covering built to a slight fall to drain off rain water. The most common covering material is bituminous or roofing felt. The felt covering is built up in layers each bonded with a bituminous substance such as tar. The upper surface is sometimes covered in a layer of stone chips set in tar to make it more robust, weatherproof and better able to deal with solar gain (this is the amount of heat which the roof structure absorbs from the sun).

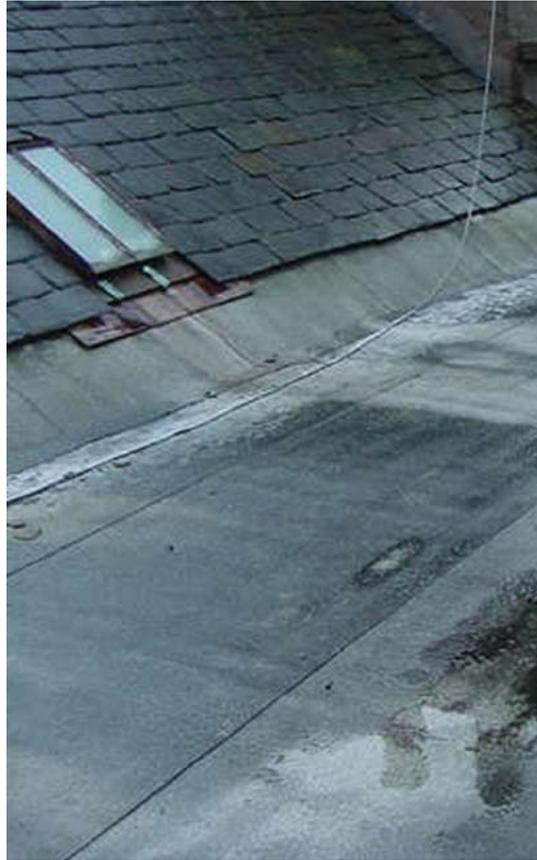
Standing water is a major source of deterioration in flat roofs

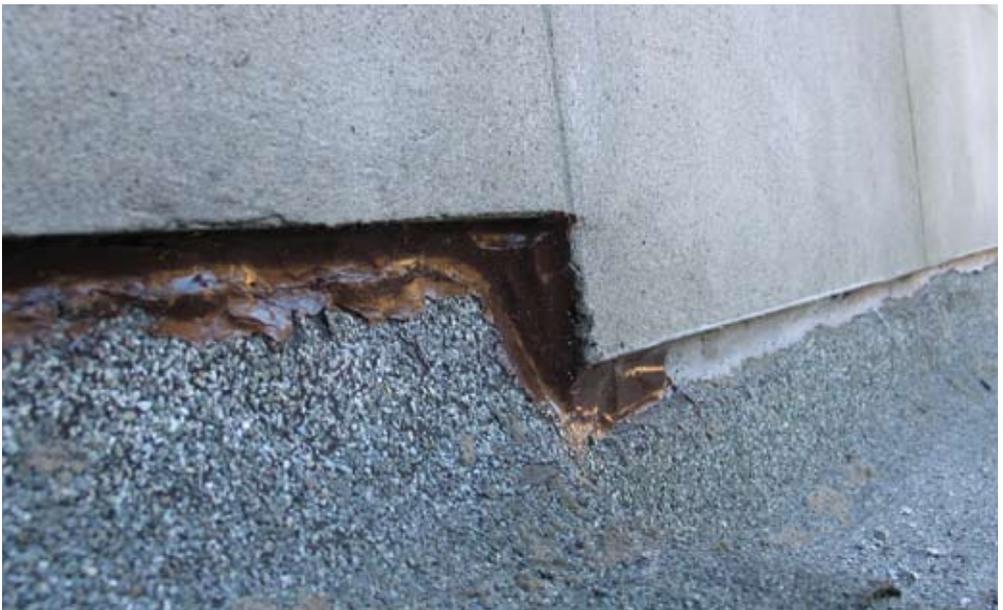
Repair to detailing where flat roof meets parapet wall

A further problem that may be encountered along the edge of flat roofs is that of split, torn or damaged skirting resulting in water ingress. Skirting occurs where the edge of a flat roof meets the masonry parapet. Deterioration can be caused by thermal or moisture movement, a lack of an adequate key to the backing or simply a failure in the original design or workmanship. Where this occurs the skirting will have to be repaired or replaced, and is best undertaken by an experienced contractor.

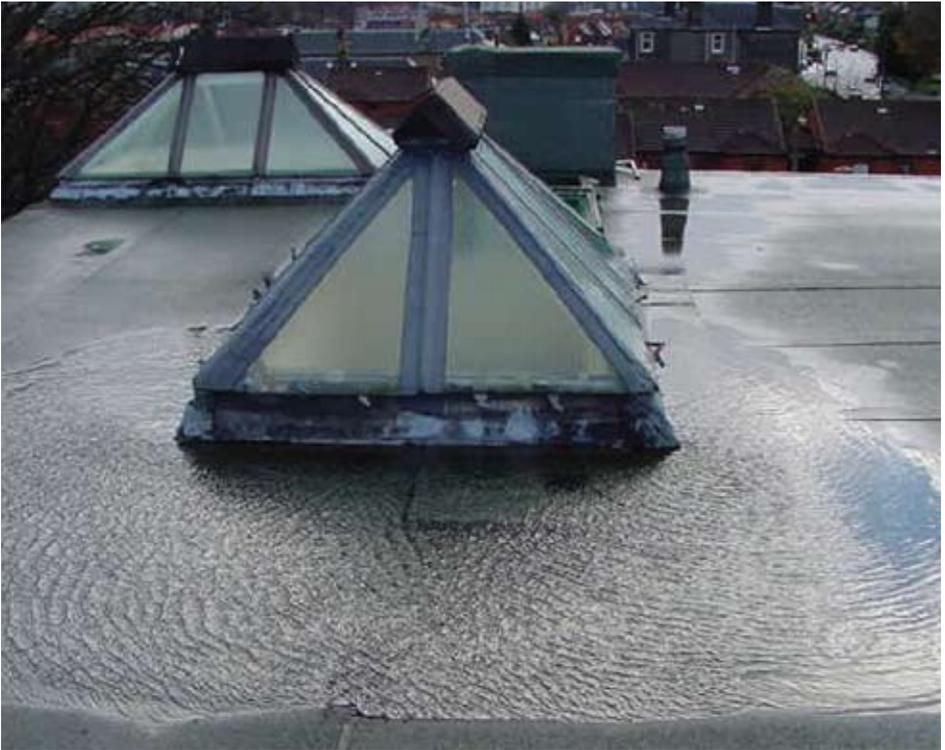
Pooling water around a roof light will lead to major deterioration of both the roof light and the flat roof

There a number of potential failures which can occur in the area surrounding a roof light or other opening. Wind damage to flashings, defective sealing around the base of the roof light and rotting or degraded timber elements can occur. These should be repaired by making good flashings, ensuring seals are sound (replacing them where necessary) and renewing the frame if rotten.

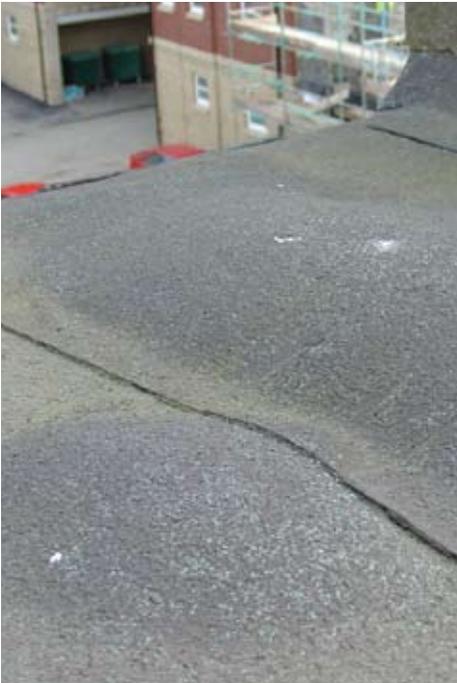
Blistering of roof felt

Blisters can be caused by water vapour pressure occurring below the roof covering. The blister should be cut and then re-bonded to the underlay allowing any trapped moisture to escape first. The source of the moisture should also be traced and rectified.

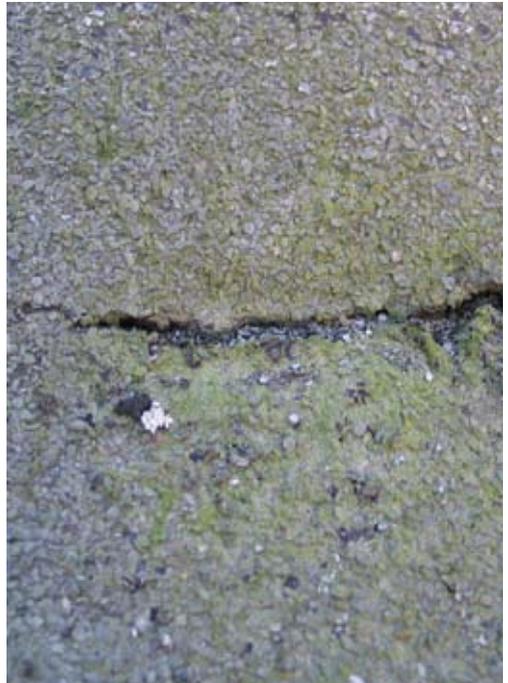
Tear in roof felt

Cracks and tears along the line of the support joists of the roofing deck can be caused by thermal or moisture movement, saturation of insulation or sagging of the roof deck. This

can be repaired by cutting back the existing felt and allowing the area to dry before applying a new layer of high performance felt with a suitable overlap between the new and existing material.

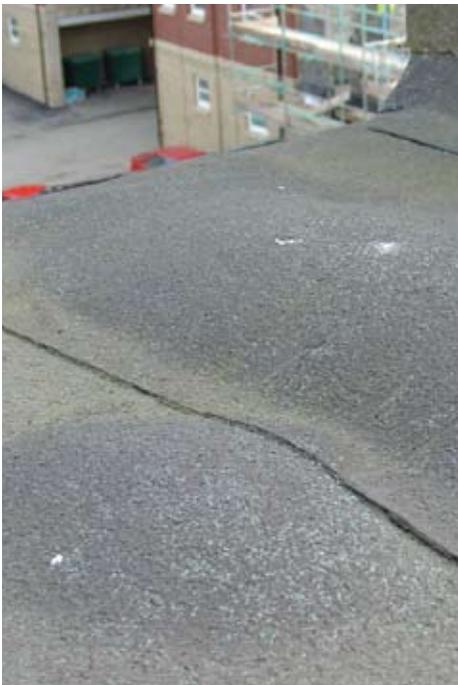
Blistering of roof felt

Blisters can be caused by water vapour pressure occurring below the roof covering. The blister should be cut and then re-bonded to the underlay allowing any trapped moisture to escape first. The source of the moisture should also be traced and rectified.

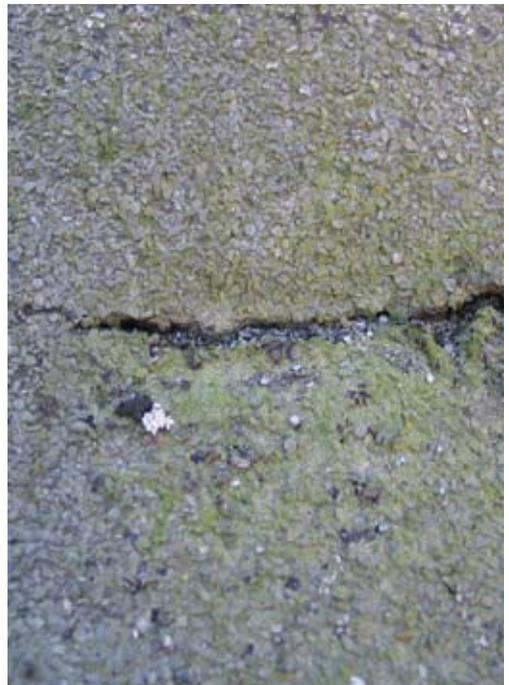
Tear in roof felt

can be repaired by cutting back the existing felt and allowing the area to dry before applying a new layer of high performance felt with a suitable overlap between the new and existing material.
